Is It Modified?

CECOM Safety-of-Use Message (SOUM) 92-02-01 said to apply MWO 11-5985-357-30-1 to the OE-254 antenna, NSN 5985-01-063-1574.

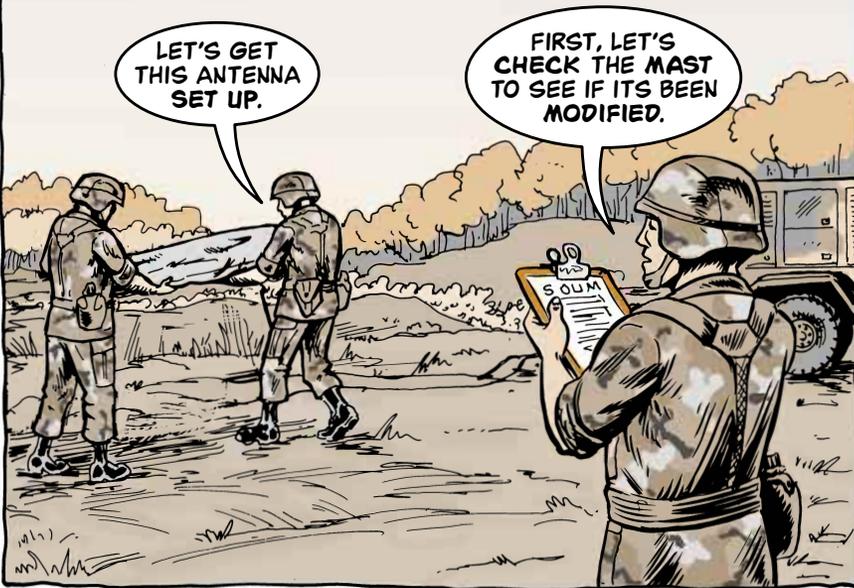
The MWO extends the life of the antenna support sleeves, mast sections, and mast and base assembly by eliminating a cause of stress cracks.

So check out your OE-254 to make sure the MWO has been done. If the MWO has been done, the tabs and notches will be removed from the mast sections. If your mast still has its tabs and notches, send it off to support for the MWO. Also send the mast and base assembly and the two antenna support sleeves.

Inspect the antenna mast section poles for stress cracks at the squared corners of the notch. If you find any cracks that extend more than 2 1/2 inches from the bottom of the pole, it can't be modified, so just turn it in and get a new one.

The modified mast will be one section shorter, but will transmit as well as ever and last longer, too.
