Hot Topic Item. M4 / M16

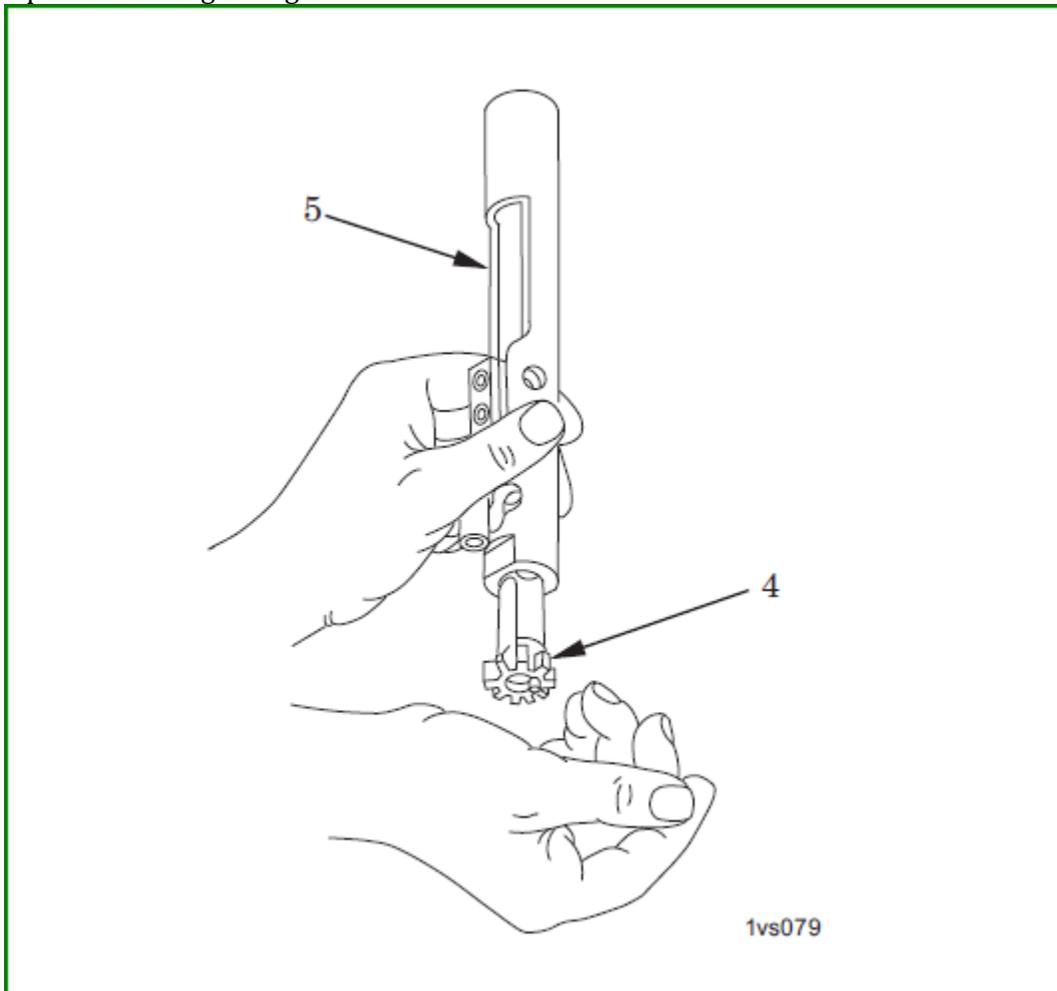
It has come to our attention via PDQRs and reports from the field that there has been three significant issues with some bolt carrier assemblies, (NSN 1005-01-441-1619, Part Number 8448505). The first issue is extensive wear and/or destruction of gas rings on the bolt itself. Testing confirms that the interior chamfer on *some* bolt carrier assemblies is not to specification. As a result, when the weapon is fired, there is a loss of gas pressure which reduces the cycle rate of rounds or jams the weapon. The loss of gas pressure is caused by the gas rings being damaged when the bolt is installed into the assembly or through damage incurred by firing the weapon.

If the user cannot perform these tasks, then there is a good possibility that your weapon may have a deficient bolt carrier assembly.

Our recommendation for avoiding this issue is as follows: Remove the bolt from the bolt carrier assembly and visually inspect the gas rings for excessive wear or damage. Next, perform Work Package 0011-6, Figure 8, step 9 of the TM 9-1005-319-23&P, checking for fit of the bolt assembly.

Check bolt assembly (4) for proper fit with bolt cam pin removed. Turn key and bolt carrier assembly (5) and suspend so the bolt assembly is pointed down. The bolt assembly must not drop out. If weight of bolt assembly allows it to drop out of key and bolt carrier assembly, you must replace the bolt gas rings.

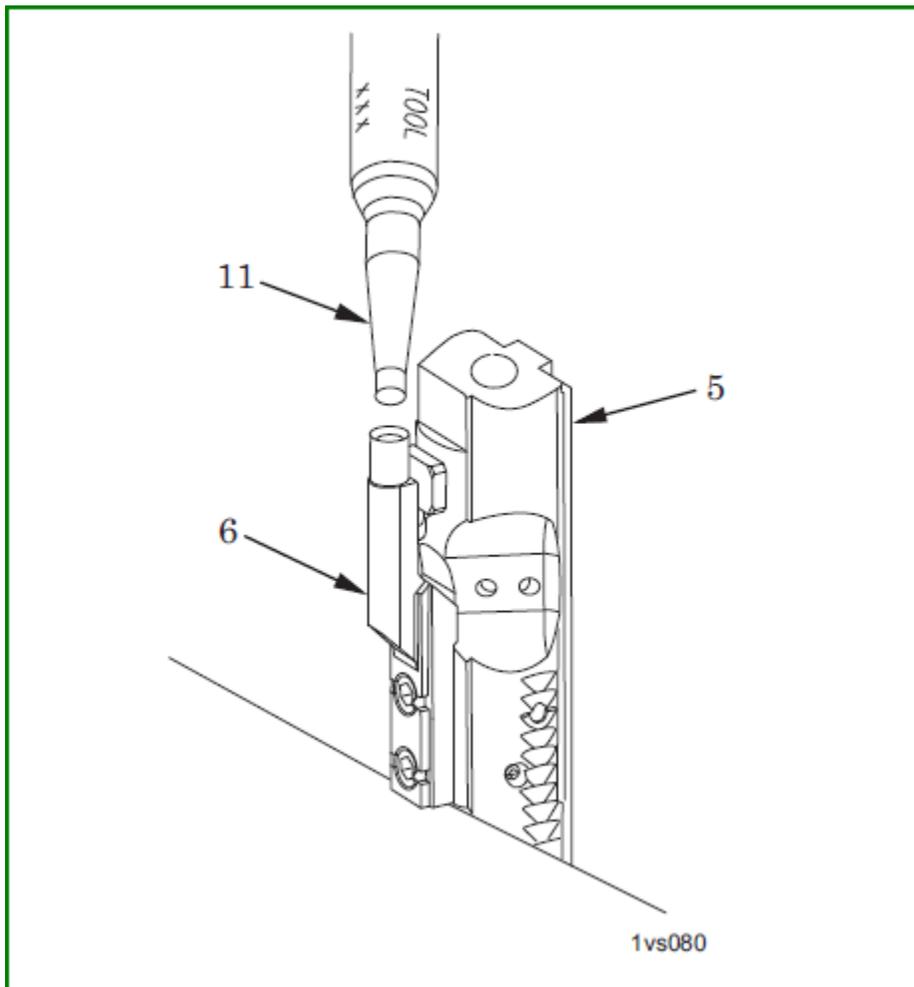
We have also received reports from the field indicating there have been some carrier keys that do not have the correct inside taper. This may cause miss alignment with the gas tube. The result of misalignment of the gas tube is a loss in gas pressure and potential damage to the gas tube itself. Special machine key tool, NSN 5315-01-310-0370, should be used to check the correct taper of the bolt carrier key.

1. Repair small dents and/or distortions in carrier key (6) using bolt carrier key tool (11) as follows:
 - a. Place the key and bolt carrier assembly (5) in a vertical position, supported so that contact is made with the rear surface of the carrier key (6).
 - b. Insert the small end of the key tool (11) into the tube portion of the carrier key (6).
 - c. Strike the large end of the key tool (11) lightly with a 4-ounce, soft-brass hammer.
 - d. Repeat striking (gently) until carrier key (6) is reformed to original configuration.
 - e. If carrier key (6) cannot be reformed to original configuration, see WP 0013 for replacement.
2. Replace all authorized unserviceable items. Retest all replaced parts.

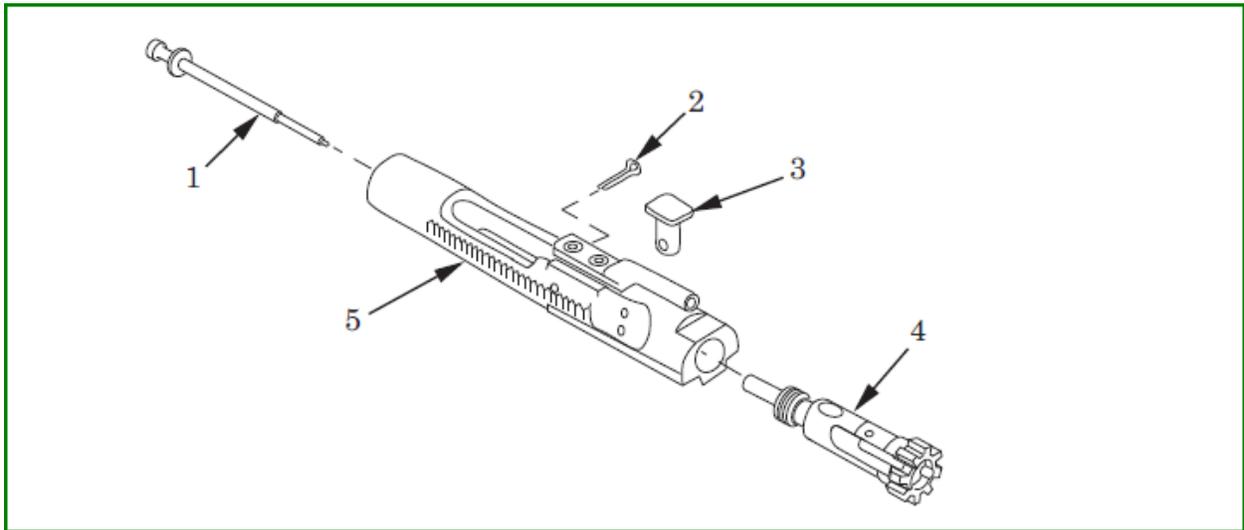
Lastly, we have received reports from the field that there has been trouble with some bolt carrier assemblies having an improper chamfer where the bolt cam pin is installed. This will lead to an inability to install the cam pin into the assembly. As a result, the weapon will not be mission capable.

1. Lubricate parts; refer to TM 9-1005-319-10.

Before installing bolt assembly, check to see that the bolt ring gaps are staggered to prevent loss of gas pressure.

2. Install bolt assembly (4) into key and bolt carrier assembly (5).

3. Install bolt cam pin (3) and rotate one turn to secure bolt assembly (4).

4. Hold key and bolt carrier assembly (5) with bolt assembly (4) down and drop in firing pin (1).

5. Install firing pin retaining pin (2) from left side only to ensure proper installation. Check installation by attempting to shake out firing pin (1).
