# Down the Drain

MY ANGLE DRIVE SHAFT IS SEIZING FROM RUST!

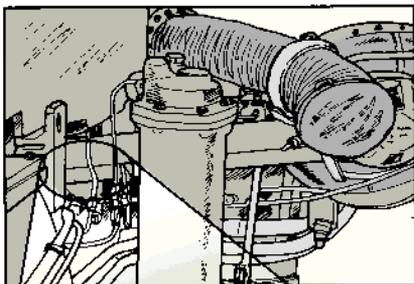
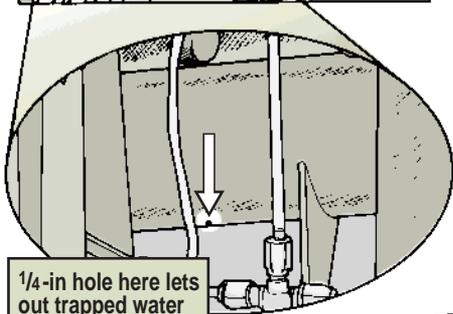
Water from washing, rain and condensation always seems to pool in the worst possible places on our tanks. One of those places is the left side angle drive shaft cover.

When the drive shaft sits in water long enough, rust develops. Pretty soon, the shaft won't move the fan and your engine isn't getting the airflow it needs.

1/4-in hole here lets out trapped water

We've stopped this problem by drilling a 1/4-in hole in the bottom of the lowest portion of the cover. Water drains away as fast as it comes in and the drive shaft stays rust-free.
