Keep the Sight Cool

OH-58 crews, if the turret on your Kiowa Warrior's mast-mounted sight (MMS) is getting sluggish, maybe the problem is old antifreeze.

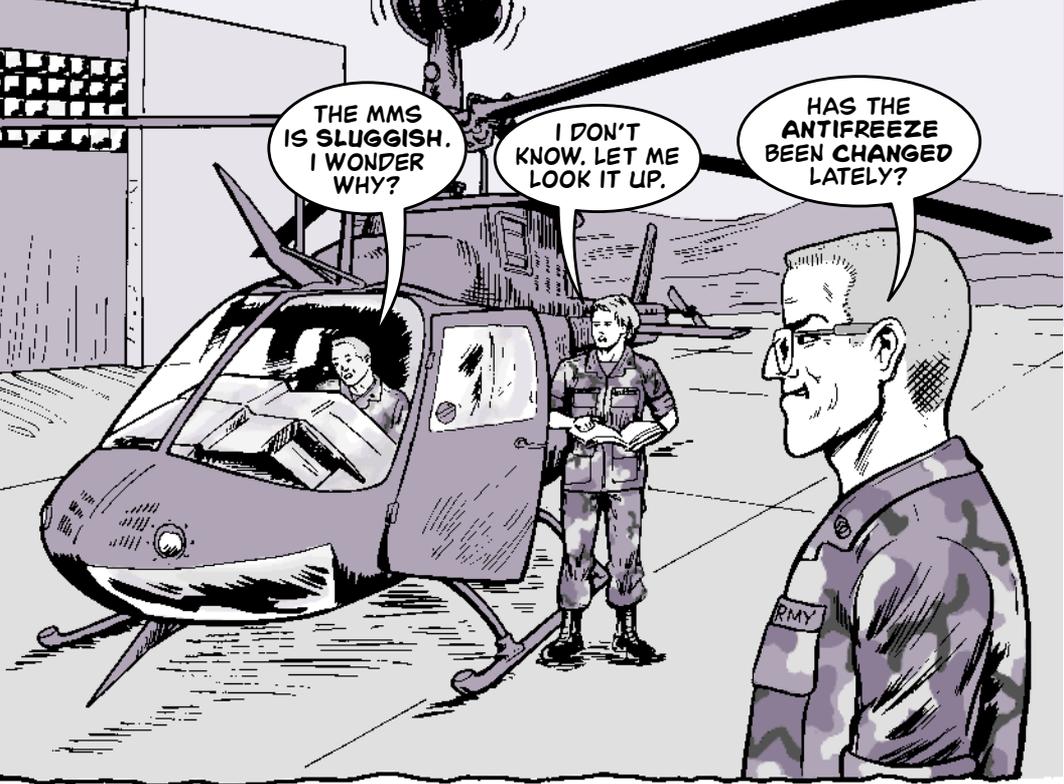
The MMS turret is cooled with common automotive antifreeze. Over time, the additives in the stuff can form gummy deposits that block circulation and cause the turret to slow down or overheat.

The solution is to have your AVIM shop change the coolant now and after every 300 flight hours of operation.

All coolant changes require the use of the existing turret holding fixture, NSN 4920-01-231-8514; the thermal control unit (TCU) service unit, NSN 3460-01-346-1792; and the TCU power breakout box, NSN 4920-01-231-8512. Operation of the holding fixture, TCU service unit and TCU power breakout box are described in TM 9-4935-778-13&P.
