Don't Be a Glass Cracker

Mechanics, easy does it on the M113A3's bilge pump sight glass.

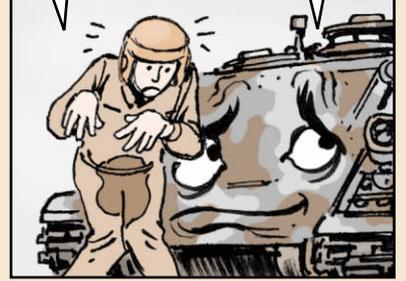
It's made of plastic so it cracks easily as you tighten down the clamp nuts.

A cracked sight glass delivers a lap full of water to the driver the next time the bilge pump is turned on. That's sure to get you scratched off next year's Christmas card list!

A big leak from the sight glass is considered a Class III leak, too. That means the carrier is NMC until the sight glass, NSN 9330-00-782-1832, is replaced.

Cracked sight glass leaks enough to make vehicle NMC

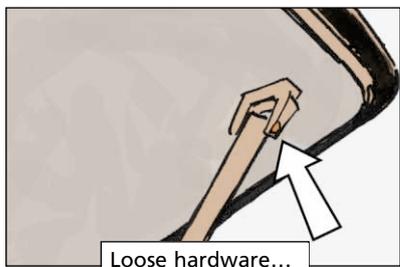
If the hardware loosens, the arm rattles around from vibration. It doesn't take much movement to free the arm's tip from its storage bracket.

Loose hardware...

During your before-operation PMCS,

take a close look at the support arm hardware. If it's loose, take a few seconds to tighten it up.

If the support arm comes loose a lot, try a few drops of sealing compound, NSN 8030-00-081-2339, on the hardware threads. That should keep the support arm in place.

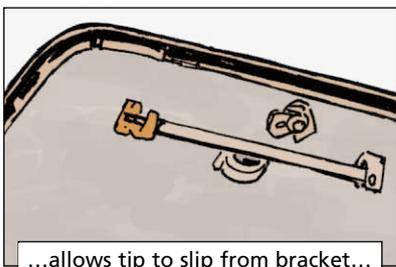
...allows tip to slip from bracket...

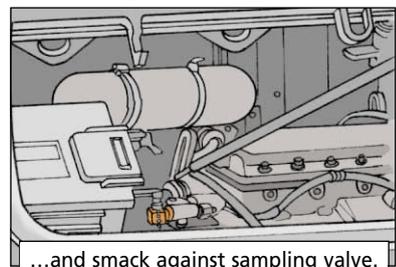
When that happens—WHAM!—right into the AOAP sampling valve. The valve is damaged as the tip of the support arm bounces against it over and over. You won't even realize the damage is done until the next time you open the engine access cover.

...and smack against sampling valve.
