Close the Door on Cowling Headaches

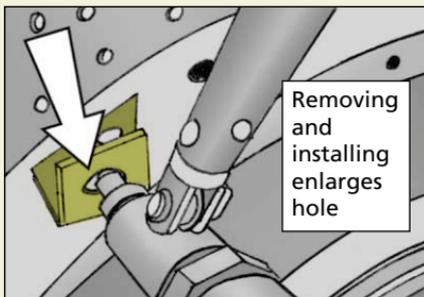
We've had a constant problem with the Chinook engine cowling door retaining clip. Aircraft vibration and constant storage and removal of the strut enlarges the clip's hole to the point that the strut just falls out of the clip on its own.

1. With a drill index, mark a $3/16$ -in diameter hole around the existing hole. Enlarge the hole with a rotary file to the marks.
2. Drill a $25/64$ -in hole in an eyelet, NSN 5325-00-282-2047, using a vise and drill press.
3. Insert the eyelet into the retaining clip and add a retaining ring, NSN 5325-00-598-1474. That holds the strut in place.

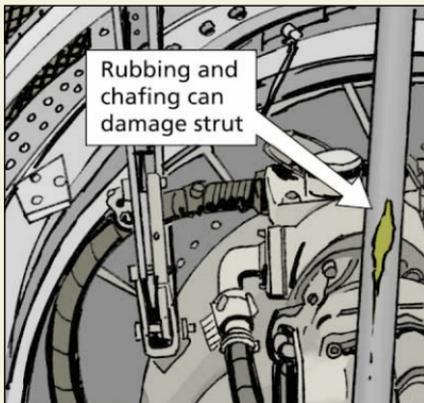
When the strut falls out, it rubs against the top of the engine, the main fuel filter housing and the fuel line. Over time, that could cause a fuel leak and fire. The strut can also bend until it won't hold the cowling door open.
