# 40 MPH Speed

Unless your M939-series 5-ton trucks have had MWO 9-2320-272-55-1 applied, their highway speed limit is still 40 mph.

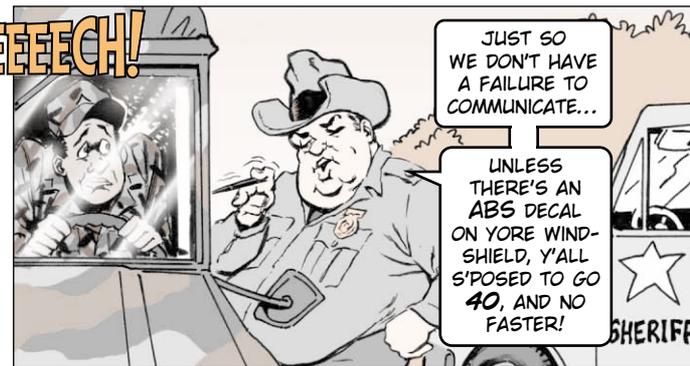
Trucks with the ABS MWO have a yellow triangular decal with black lettering "ABS" in the lower left corner of the windshield. 'Course, there'll be a regular MWO tag on the cab reinforcement just inside the driver's door, too.

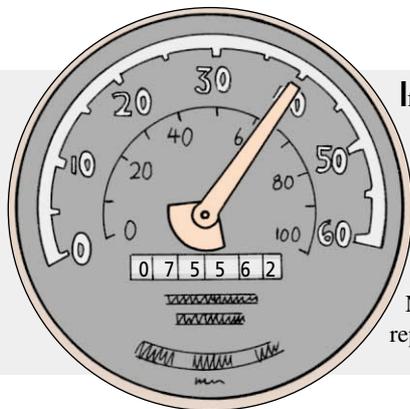
If your M939-series 5-ton truck has a speedometer that does not work right or doesn't work at all, your truck is NMC until it is repaired or replaced.

Since no M939-series truck can be driven faster than 40 mph unless MWO 9-2320-272-55-1 has been applied, you must have a working speedometer to know how fast you're going.

Insert these words in TM 9-2320-272-10 on Page 2-53 in PMCS Item 19's "Not Fully Mission Capable If" column:

"Gauges—speedometer/odometer is inoperative. Report vehicle immediately to unit maintenance if speedometer needle does not move, jerks unevenly during sustained speeds or appears stuck."
