TAKE TIME TO TAPE APU

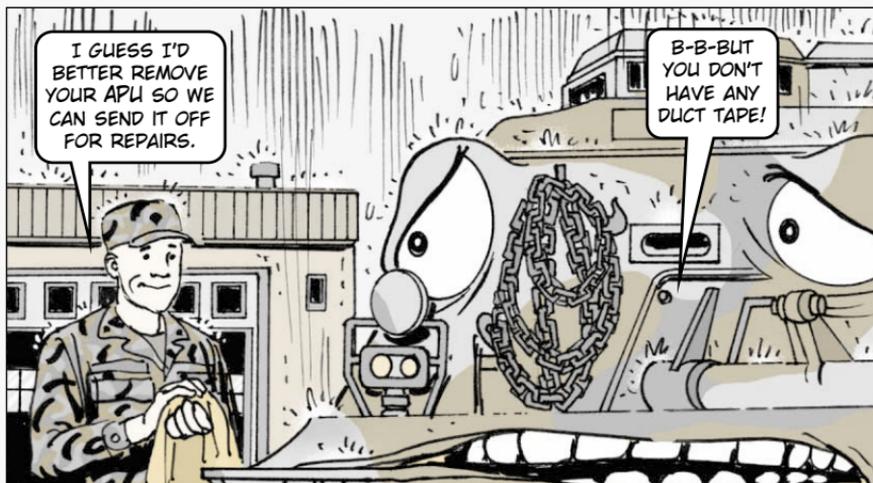
When the APU is removed, the exhaust port is left wide open. That lets water—from rain, condensation or any other source—inside the APU. The water seeps past the exhaust valves, enters the combustion chamber and rusts the piston to the side of the cylinder.

Most of this damage could be prevented if mechanics would seal the exhaust port with a piece of duct tape immediately after removing the APU. That keeps water out and damage to a minimum.
