FIRE WIRE NEEDS A DIP

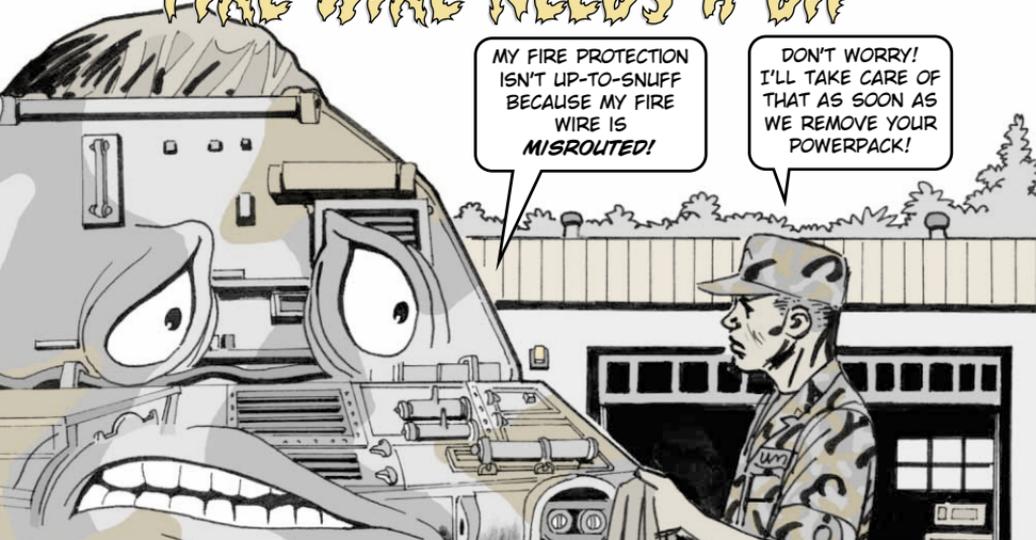
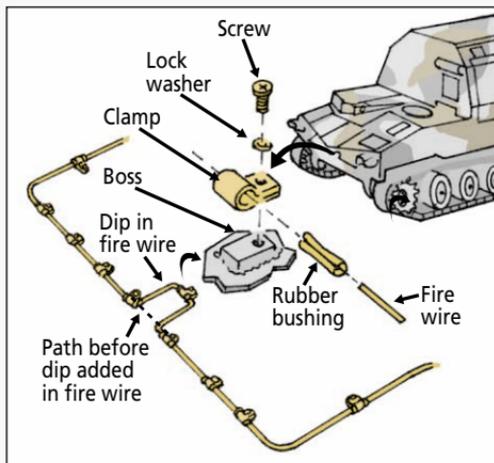
The fire wire in the lower front of the engine compartment of some M992A2 ammo carriers has some extra slack, mechanics. During production, that slack was coiled in the corner of the engine compartment to keep it from getting cut or damaged.

Problem is, the extra wire was supposed to be formed into a dip at the front of the engine compartment to provide better fire coverage.

If your carrier has a serial number of 821 or higher, you'll need to secure the extra wire the next time the powerpack is removed. Just gather all the slack in the middle of the engine compartment and clamp the fire wire in place to the existing boss on the carrier's hull.

Item	NSN
Rubber bushing	5365-99-881-6505
Loop clamp	5340-00-057-2890
Lock washer	5310-00-045-3296
Machine screw	5305-00-984-6208
