COUNTERMEASURE SET UPGRADE

UH-OH! NO FILTER!

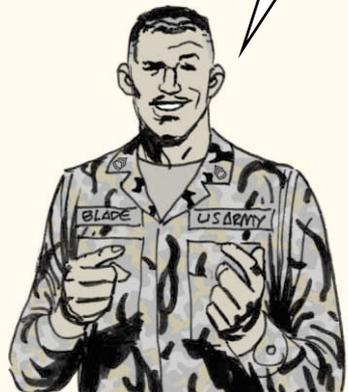
To determine if your countermeasure set needs an upgrade, check the A9 card for a red strip on the U4 chip and a red dot on the S1 thumb wheel switch.

If EPROM chip (U4) has a red strip marked, width-wise across the top back portion...

IF U4 IS MISSING A WIDTH-WISE RED STRIP OR S1 IS MISSING A RED DOT ON THE SIDE, CONTACT CECOM'S CLIFF VERMONT AT DSN 992-2472, (732) 532-2472 OR E-MAIL cliff.vermont@mail1.monmouth.army.mil FOR UPGRADE DETAILS.

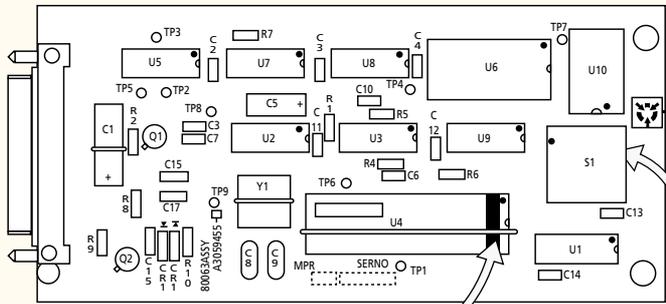
...and thumb wheel switch (S1) has a red dot on its side, then no upgrade is required

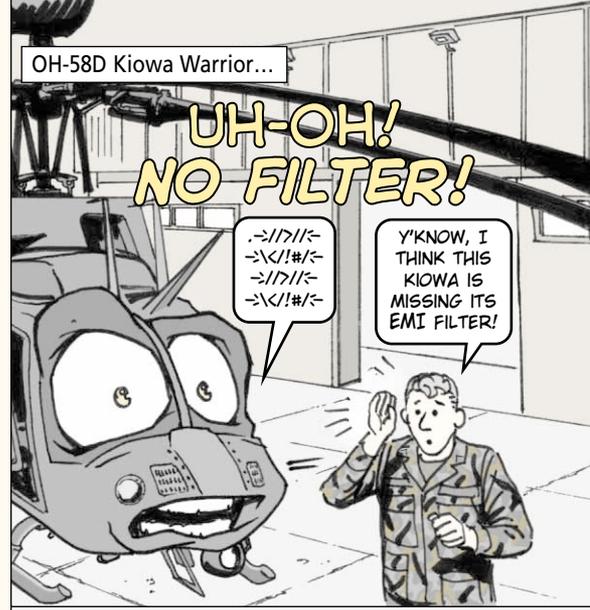
Some Kiowas' Block 1 Air-to-Air Stinger (ATAS) interface electronics assemblies (IEA) were installed before it was decided to add an electromagnetic interference (EMI) filter to the J1 connector.

Without the EMI filter, static could affect the Kiowa's commo. MWO 9-1440-431-50-1 (Oct 01) authorized the filter.

It's simple to check if the filter has been installed. Disconnect the J1 connector at the IEA. Look at the area at the base of the pins. If the filter's been installed, you'll see "EESeal". Not there? Contact your AMCOM logistics assistance rep. He will arrange for the MWO to be done. The AMCOM POC for the MWO is Cynthia Walker. Contact her at (256) 876-3515/DSN 746-3515 or e-mail cynthia.walker@redstone.army.mil.
