GO EASY ON PULLING AND TUGGING

Be careful, mechanics, when you remove your Black Hawk's T-700-GE-700 series engine oil cap to add oil.

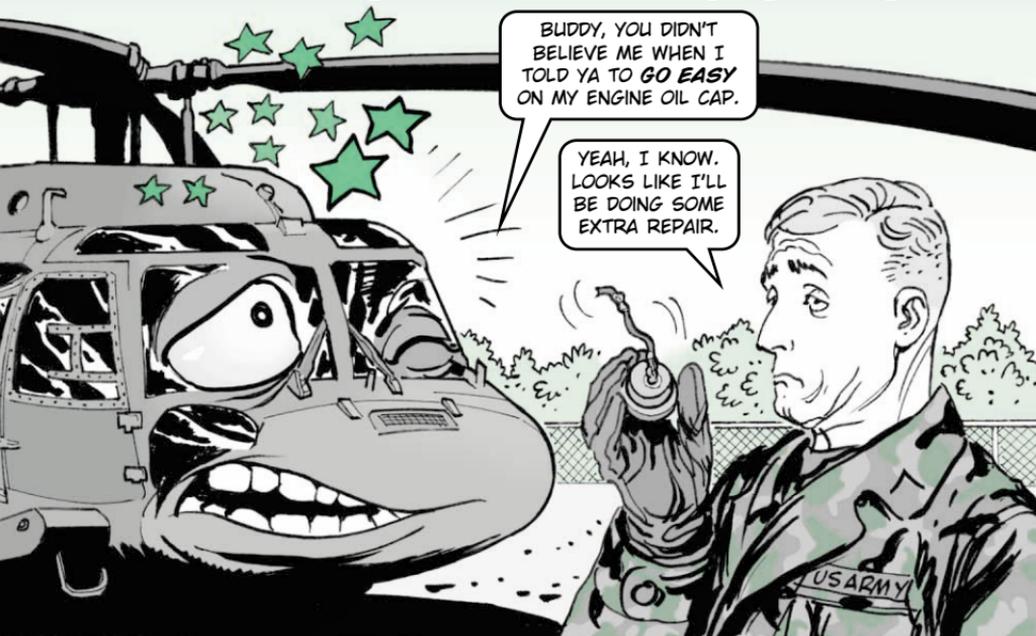
When the cap and O-ring stick, some mechanics muscle off the cap. Instead, they should twist the cap back and forth to loosen it and then ease the cap off.

The cap has a short cable that's attached to a metal tang on the screen. If you use force to pop loose the cap, you can jerk the cable and snap off the metal tang on the screen assembly. That screen keeps FOD from entering the oil tank while the cap is removed.

Pulling and tugging too hard leads to replacing the oil cap and filler assembly, NSN 5340-01-318-0077, for about \$330. A sticking cap is no fun to remove—but it's even less fun to replace the assembly!
