# BRUSH UP ON MINE BLADE REPAIRS

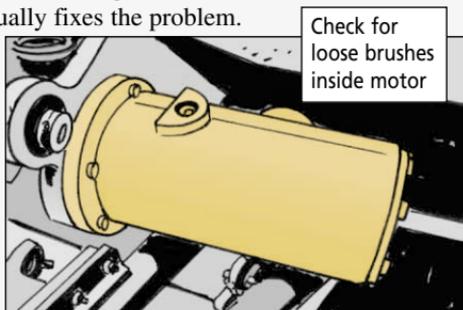
The number-one lifting mechanism problem is loose electrical brushes in the motors. That's especially true if the operator does a lot of "combat drops" or changes the motors' direction without first letting the mine blade come to a complete stop. Reinstalling the brushes usually fixes the problem.

If not, the brushes may be burned out. Install new brushes, NSN 5977-01-412-0758. You'll need four brushes for each motor.

If one of the motors, NSN 6105-01-277-0295, still won't work, you may need to replace it. At around \$3,500, that's still a lot cheaper than ordering a new lifting mechanism.
