## DISTRESS MARKER LIGHT LEAKAGE

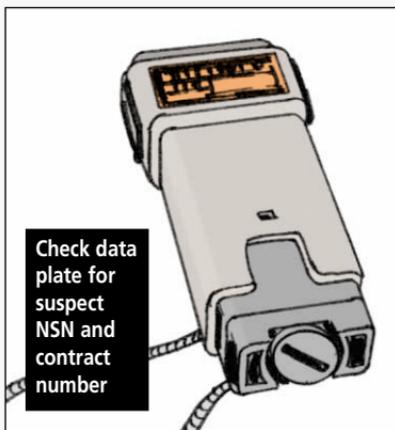
SERGEANT FUENTES, I'VE GOT A BAD DISTRESS MARKER TO TURN IN.

PROBABLY A BAD IR HOUSING. WE'LL GET IT REPLACED.

**ELSE** techs, if you've noticed visible light coming from the housing of a SDU-39/N distress marker strobe light, you have a defective infrared red (IR) housing.

Install the new housings on the body like it says in PM ACIS message (AIS02-02) and test for light leakage at all angles. If no light leaks, you're good to go. Check out all the details in the PM ACIS message.
