Them's the Brakes!

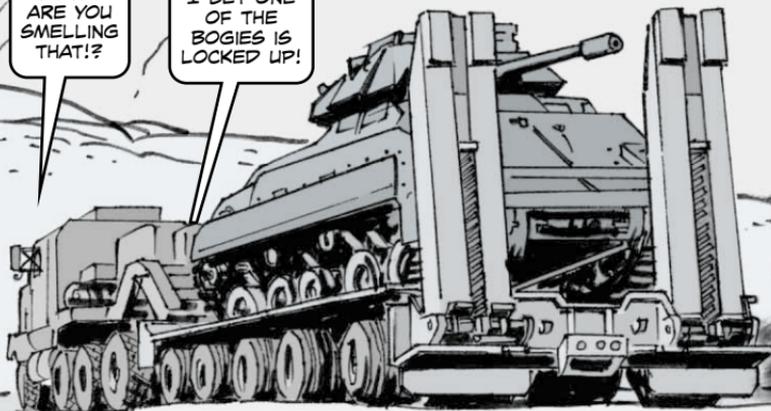
PEE-YEW!
ARE YOU
SMELLING
THAT!?

UH-OH!
I BET ONE
OF THE
BOGIES IS
LOCKED UP!

The original Anchorlok brake chamber, NSN 2530-01-329-2187, used in the M1000 is too big. It can hit the underside of the platform if the semitrailer is fully lowered. The brake chamber can even be dislodged, resulting in air loss great enough to lock up **all** the brakes on the semitrailer.

That leads to significant tire damage and, depending on road conditions, could result in your losing control of the vehicle.

To prevent this, a new Meritor brake chamber, NSN 2530-01-387-8426, was listed in Change 2 to the -24P TM. Unfortunately, some units without this change are continuing to order the old Anchorlok brake chamber.

So, right now, go check the brake chambers on your M1000. If you find any with Anchorlok printed on the top of the chamber, notify TACOM. You may even be eligible for a free-issue replacement of the brake chambers.
