YOU COULD BECOME THE NOWHERE MAN IF YOU DON'T HAVE THE LATEST SOFTWARE INSTALLED IN YOUR PRECISION LIGHT-WEIGHT GPS RECEIVER (PLGR) OR THE ENHANCED (EPLGR) MODEL.

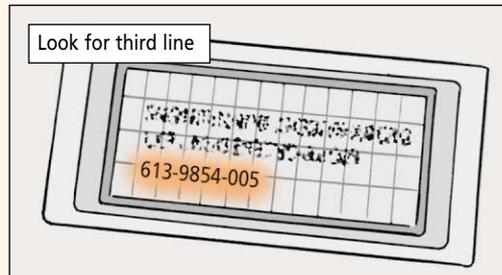
Even if you haven't had these problems, check what software you're using. As you power up the PLGR/EPLGR, look for the 10-digit number. It will be on the third line of the first display. If you're already powered up, you can find the number on a status page by using the MENU key.

If you spot numbers 613-9854-005 or 613-9868-008, you're up-to-date and good-to-go. (PLGR+96 software version 613-9868-008 is the preferred operating system if the hardware will support it.)

Any other numbers mean you need new software. See your CECOM LAR for a copy of MWO 11-5820-291-30-4. The MWO lists the software you need, tells how to install it and authorizes you to do it. Your LAR should also have a copy of the new software.
