CONNECT TO CORRECT CONNECTING LINK

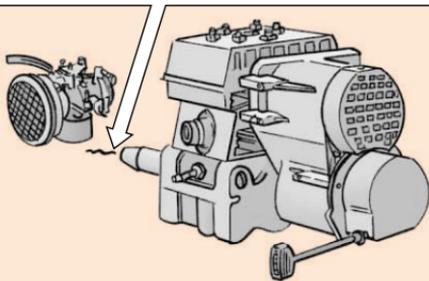
In my role as a roving troubleshooter/inspector for the M17-series decon, I find that 25 percent of the M17 connecting links between the carburetor and the engine vane are either missing or have had a piece of coat hanger substituted.

The result is the engine governor vane gets bent in the engine housing and the M17 engine can't reach high enough rpm to decon properly. There is no replacement vane. The only fix is to buy a whole new engine block for more than \$3,000.

Don't try to fabricate a link.
That damages engine vane.

Use the correct connecting link, NSN 3040-01-356-6947, and give the reshaped vane a try. If it works, you've saved \$3,000.

Never try to fabricate a connecting link. When a link is damaged or missing, order a new one. The link costs less than \$6. It's not worth risking a \$3,000 engine.

If connecting link disappears, order a new one.
