M1A2
SEP Tank...

**ASK FOR A
RE-DEAL**

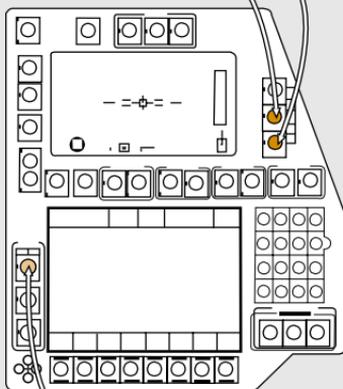
1. Make sure the tank's MASTER POWER and TURRET POWER are on.
2. Press the DIAG push button on the Commander's display unit (CDU) to enter the diagnostic menu.

Turret power
Master power

DIAG pushbutton
