# HEAT IS HARD ON TRACK

# KEEP THE COOL AIR FLOWING

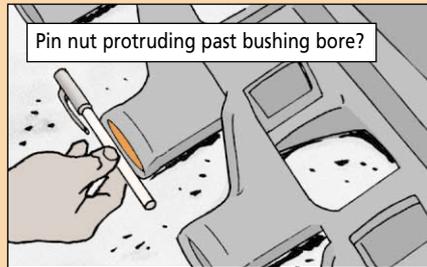
When operating on improved road surfaces at increased convoy speeds (faster than 25 mph) and when temperatures are at or above 100°F, track bushings tend to soften. That allows the bushing pin to move around and extend out of the bushing bore. Protruding pins make your vehicle NMC.

*Crewmen should check for track pin movement and inspect track tension hourly, or as soon as the tactical situation permits.*

*If you find protruding pins, you can—as a BDAR fix only—hammer the pins back into place and continue operating until the vehicle reaches a safe location for repair. However, you must mark the bad bushing so that it is easily identified when repairs are possible. The best way to do this is by scribing a mark on the metal surface of the affected shoe with a screwdriver.*

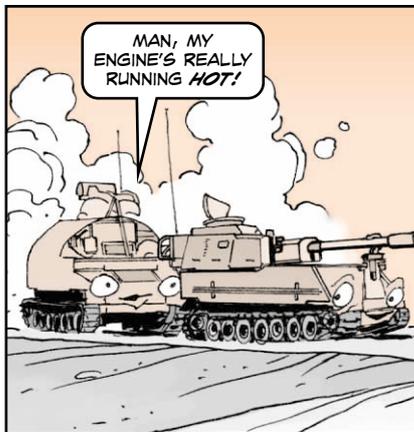
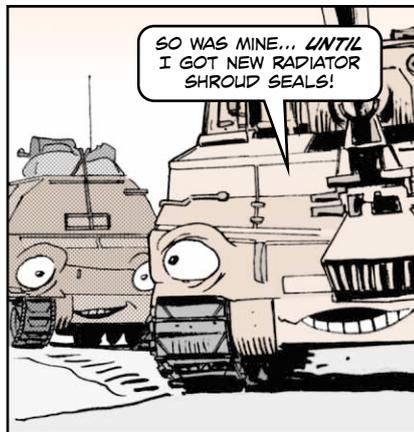
**M**echanics, if you've been getting complaints of a hot-running engine in an M109-series howitzer or M992-series ammo carrier, make the radiator shroud seals one of your first checks.

Those seals form an air barrier between the radiator and fan tower. That barrier increases air flow across the radiator to keep the engine cool. If seals are missing, torn, squashed or mangled, air escapes around the sides of the radiator. Engine temperature goes up.

Have your mechanic check out the shroud seals next time the pack's out. If the seals are missing or damaged, he'll order new ones.

NSN 5330-00-102-9927 gets a seal for the right or left side. NSN 5330-01-314-1439 gets a top or bottom seal for the M109A6 and the M992A2. A top or bottom seal for the M109A2-A5 comes with NSN 5330-00-899-5220.
