Check for MWO NOW

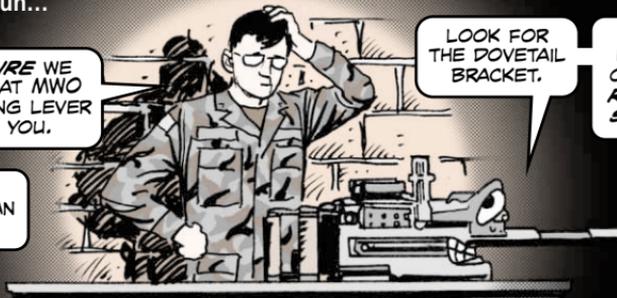
I'M *NOT SURE* WE EVER HAD THAT MWO ON THE COCKING LEVER DONE FOR YOU.

WONDER *HOW* I CAN TELL?

LOOK FOR THE DOVETAIL BRACKET.

IT'S HERE ON MY *RIGHT SIDE.*

All MK19 machine guns should have had MWO 9-1010-230-50-1 applied to them by now. The MWO changed the MK19's cocking lever from a one-piece to two-piece design that will improve the gun's safety and reliability and eliminate out-of-battery firing.

But some MK19s were missed—and that's why TACOM needs your help, armorers. Check your MK19s now to see if they've gotten the MWO. If they've been modified, they have a dovetail bracket mounted on the right side of the receiver and an "-M" stamped on the left side immediately following the weapon's part number.
