Stryker...

CHANGE COM PORT SETTINGS MANUALLY

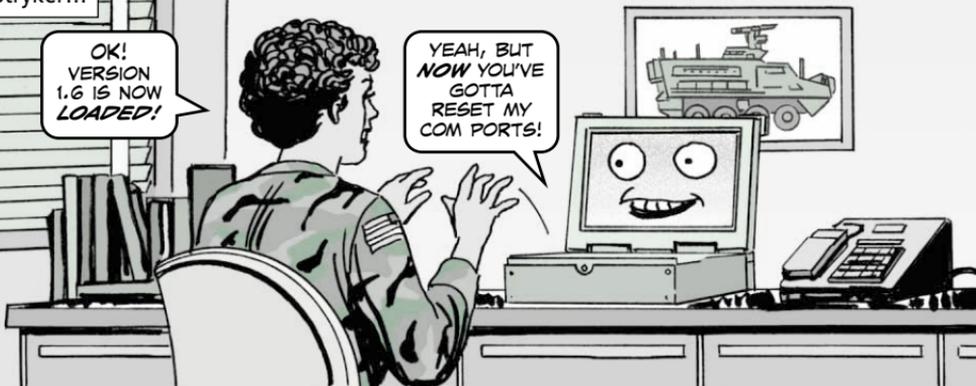
OK!
VERSION
1.6 IS NOW
LOADED!

YEAH, BUT
NOW YOU'VE
GOTTA
RESET MY
COM PORTS!

National Instrument software version 1.5 for the RS485 PCMCIA card locks up the MSD. That was fixed with version 1.6. Unfortunately, loading version 1.6 changes the hardware configuration (com ports) on the MSD from the required 2-wire setting to 4-wire.

TO CHANGE
THE MSD COM
PORTS BACK TO
THE **CORRECT**
SETTINGS,
FOLLOW THESE
STEPS...

1. Right click on My Computer.
2. Select Manage.
3. Click on Device Manager.
4. Double-click Ports (Com & LPT).
5. Double-click NI PCMCIA-485 port 1 (com 5). Depending on the card it may have a -2 after the 485.
6. Click on the Port Settings tab at the top of the window.
7. Click on the Advanced button. The Transceiver Mode should be 2 Wire TxRdy Auto. If it's not, click on the drop down menu and change it.
8. Repeat steps 5-7 for NI PCMCIA-485 port 2 (com 6).
