DO NOT OVERTORQUE

THIS WASHER FIX FOR THE CABIN FLOOR IS JUST WHAT THE DOCTOR ORDERED.

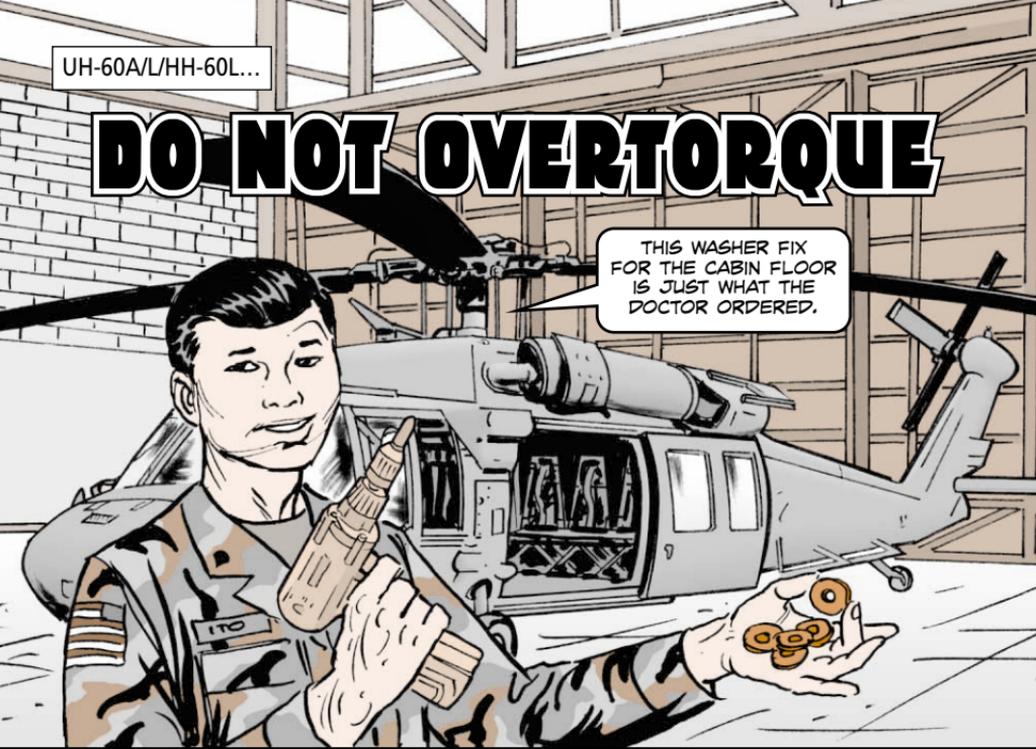
Some Black Hawk mechanics get a little careless and don't properly torque the cabin floor screws.

The screws are countersunk into the floor. You should use only enough force to seat the screws, then torque to 20 lb-in. But when some mechanics tighten the screws, they force them all the way through the floor.

We've come up with a fix to help us deal with the problem of stripped out holes. We install a larger stainless steel washer under the existing washer on the screw to secure the floor. The NSN for the washer is 5310-00-221-3106, (P/N A3235-028-24A).

DEAR SERGEANT (AND EVERY-ONE ELSE), THE KEY IS TO LIMIT TORQUE TO 20 LB-IN MAX.

YOUR SOLUTION IS A GOOD TEMPORARY FIX.

MAKE SURE YOU FILL OUT DA FORM 2408-13 TO ANNOTATE THIS AS A TEMPORARY FIX SO THAT THE FLOOR WILL BE PROPERLY FIXED AT THE NEXT SCHEDULED PHASE MAINTENANCE.
