EXTRACTING A SOLUTION

M2/M3, M2A2/M3A2 Bradleys, MLRS Carrier...

16 LB-FT IS JUST RIGHT

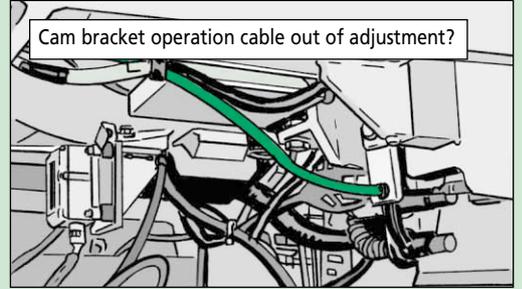
Dear Half-Mast,
We're currently going through gunnery and have had some problems with one of our M1A1 tanks. When the tank fires, the breechblock doesn't drop to allow the aft cap to be ejected from the chamber. Since we have to manually extract the aft cap, there's the additional worry about unburnt propellant and gasses causing flashback in the turret.

If the cable is too far out of adjustment, the crank boss misses engagement with the cam bracket during the counter-recoil stroke. That's what mechanically cycles the breech open so the extractors can expel the aft cap.

If the ejection problem still exists after you adjust the cable, take a look at the extractors themselves. There is a small lip machined on the upper inside edge of each extractor. These lips are what grab the aft cap and extract it. If they wear down or break, they won't grab like they should.

Dear CW3 J.H.,
From what you've said, it sounds like you may need to adjust the cam bracket operation cable.

The adjustment procedures for the cam bracket operation cable start on Page 8-70 of TM 9-2350-264-20-2-4 (Apr 03), Page 8-55 of TM 9-2350-288-20-2-4 (Aug 95), and Page 8-61 of TM 9-2350-388-20-2-4 (Feb 01).

I'd also suggest that you manually exercise the mount. Use the M-3 oil pump and get the mount out far enough that the lobe on the crank extends past the cam (about 10 inches). With the manual handle in the armed (down) position, you should be able to see the cam snap into position. Then you can let the mount back into battery and watch the breech operation.

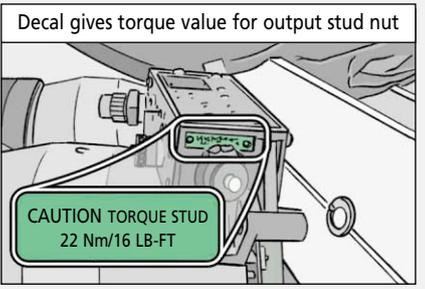
There should be a decal beside the stud nut that lists the proper torque requirement of 16 lb-ft. When some generators were rebuilt, however, the decal was removed.

As a result, some mechanics don't tighten the stud nut enough while others tighten it too much. Too loose and the nut will vibrate free. Too tight and the insulator may be damaged.

Mechanics, when you're working on the Bradley or MLRS' 300-amp generator, NSN 6115-01-458-0096, have some mercy on the output stud nut.

And no Loctite, either. That affects the torque value and can cause damage.
