TM Wrong on Mortar Clamp

MY TM—TM 9-2320-311-10-12—GIVES **BAD INFO** IN WP 0049 00 ON THE POSITION OF THE **MORTAR WIPER SEAL BAND CLAMP.**

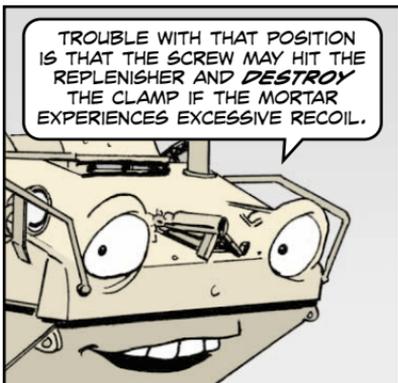
THE TM SHOWS THE CLAMP POSITIONED WITH THE TIGHTENING SCREW AT THE 12 O'CLOCK POSITION.

TROUBLE WITH THAT POSITION IS THAT THE SCREW MAY HIT THE REPLENISHER AND **DESTROY** THE CLAMP IF THE MORTAR EXPERIENCES EXCESSIVE RECOIL.
