M1070 HET...

Keep Oil Lines Separate

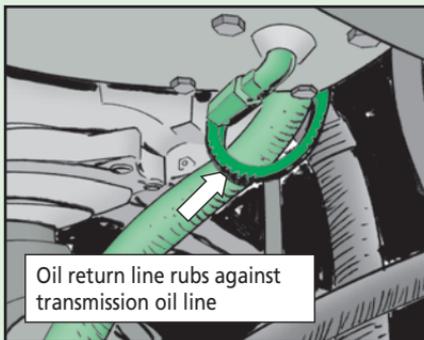
The angle of the oil return line on the rear of the M1070 tractor's air compressor allows it to rub against the transmission oil line just below it.

Enough rubbing results in a leak. And a leaking oil return line makes your truck NMC.

Oil return line rubs against
transmission oil line
