# WHAT ARE MASK MWOs?

## M40/M40A1/M42A2

## M45

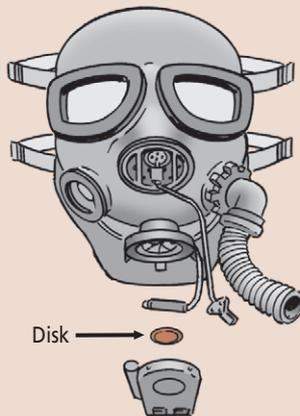
Disk

This MWO replaced the outlet valve disk with an improved disk that minimizes the chance of the disk collapsing into the outlet valve housing during extreme negative pressure checks. The NBC NCO does the MWO. All M40, M40A1, and M42A2 masks should have the modification done by 31 Dec 06. The new disk is olive green. If your masks' outlet valve disks aren't green, the masks haven't been modified.

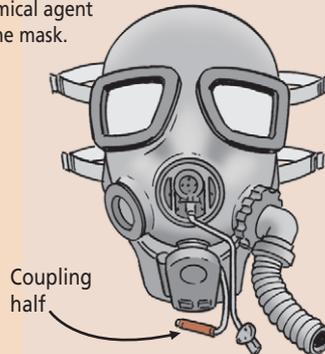
Coupling half

This MWO replaces the the quick disconnect coupling half in all M40/M42-series masks. Some of the older masks have adhesive applied to the coupling half. In that case, you must order a new facepiece. The NBC NCO does the modification. You can tell if your masks have the new quick disconnect coupling half by checking for three knurling stripes (or raised ridges) on the coupling. The old coupling had two stripes. This MWO should be done immediately because some of the old coupling halves may leak and let chemical agent in the mask.

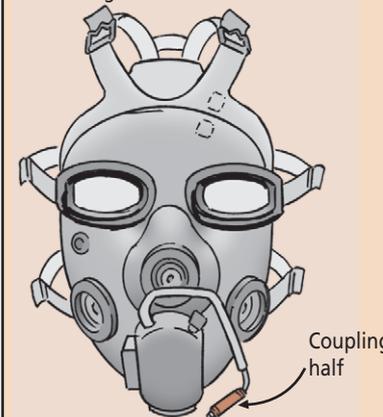
Coupling half

This MWO replaces the quick disconnect coupling half on the M45 land warrior and M45 masks. It's done by the NBC NCO. The new coupling half has three knurling stripes. The old coupling half had two. This MWO should be done immediately because some of the old coupling halves may leak and let chemical agent in the mask.
