Modern Burner Unit...

IF YOU CAN'T TAKE THE HEAT...

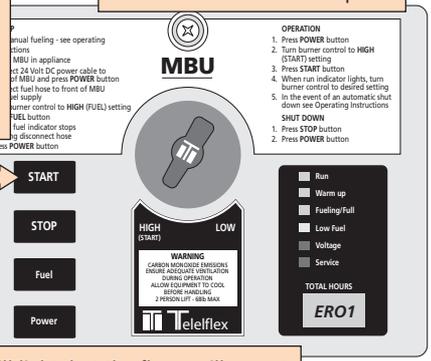
These high temperatures can play havoc with older versions of the modern burner unit (MBU) or MBUs that haven't been upgraded by MWO 7310-281-55-1. They can cause the flame sensor to fail. You need to replace the original sensor with an upgraded version that can withstand high kitchen temperatures.

1. After running for 45 minutes or so in the heat, the MBU suddenly shuts down. Error code **ER01** appears on the TOTAL HOURS display.

3. At first the burner will light, but the flame will go out within eight seconds.

Flame sensors may fail on MBUs with this version of control panel

The NSN for the flame sensor hasn't changed. It's still NSN 7310-01-462-4918. When you use this NSN to order, you'll get the upgraded sensor.
