OH-58D...

You've Just Been Reprogrammed

Mechanics, here's the latest about the thermal imaging sensor (TIS) in the Kiowa Warrior's mast mounted sight (MMS).

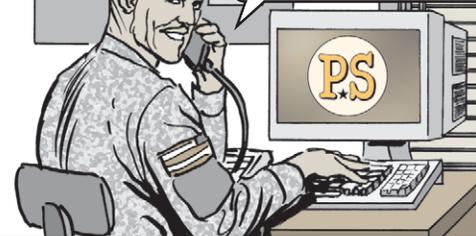
When you receive a TISU to replace a TIS, it can be installed, but it will not be operational without changes. You have to do one mandatory change and one recommended change so it will operate correctly within the MMS.

The TISU needs a reprogrammed A5A card in the master system processor (MSP) or the improved master system processor (IMSP). When the A5A card has been reprogrammed, the MSP or IMSP will get a new NSN, as will the circuit card. A large number of cards have already been updated, so compare the NSN on the box to this chart to see if you need the upgrade.

IF YOU NEED TO GET YOUR ASA REPROGRAMMED, CONTACT YOUR FORWARD REPAIR ACTIVITY OR YOUR MMS CONTRACTOR FIELD SERVICE REPRESENTATIVE.

The TISU works best if you change to the newest Kiowa Warrior version of the upper shroud, NSN 1260-01-479-4629. If you keep the old shroud it will somewhat degrade the output performance of the TISU. However, the TIS will still work just fine with either the new or old upper shroud.

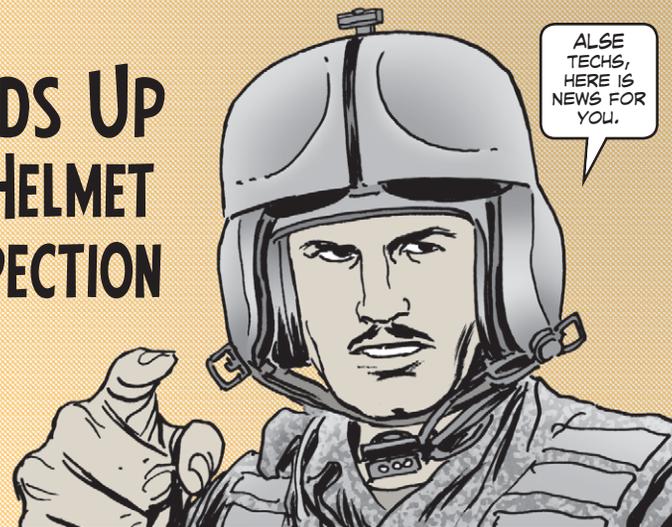
The TACOM-RI headshed says the inspection interval for the integrated helmet and display sight system (IHADSS) has changed.

The inspection requirement on the helmet is now 180 days instead of 120. That's because the headshed wants the inspection to fall in line with that of the survival vest.

This info is contained in PM AW advisory message ELSE 06-02. You'll need to make a note of it until TM 9-1270-233-23&P and IETM EM 0126 (TM 1-1520-Longbow/Apache) are changed.
