MODIFICATION AWARENESS

There's a modification for some 18K BTU environmental control units (ECU), NSN 4120-01-327-1316, so they can work properly in signal shelters. The modification was made to the thermistor because of poor ductwork in those shelters. The lack of proper ductwork kept the ECU short-cycling.

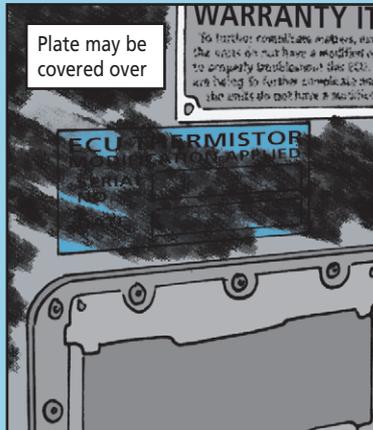
Unfortunately, for reasons like careless painting and loss, that data plate is often unreadable. When a modified ECU is placed on a non-modified shelter, the compressor will not come on in the cool mode and the temperature will become uncontrollable.

Look for the modification data plate

Handwritten note: This is the modification data plate. It is located under the standard data plate on the ECU.

Plate may be covered over

Before an 18K ECU is installed in any shelter, look for the data plate to see if it has been modified. If the plate is there, you know what to do next. If the plate is not there (or is covered over by paint) don't assume the modification has not been made. Check it out. Here's how:

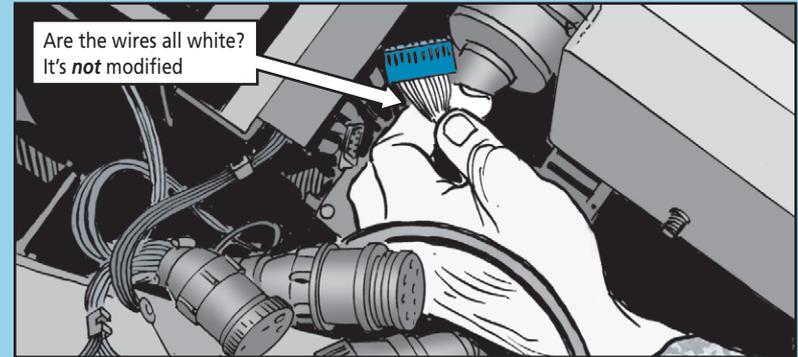
* Remove the top cover and look at the J3 connector at the logic box.

* Is the standard white mil-spec wiring in place in pins 1 and 2 going down to the thermistor? If so, you have a standard, non-modified ECU.

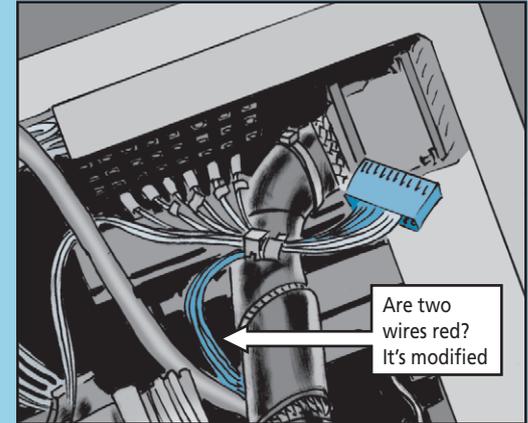
* If the standard white mil-spec wiring is not there, but red wiring is, your ECU has been modified and is now only compatible with a modified shelter.
