THE WORD IS OUT

CH-47D/UH-60 Series...

BLACK HAWKS AND CHINOOKS, YOUR RADARS ARE BEING MODIFIED!

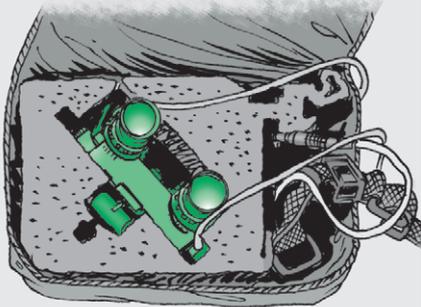
ANVIS returned from unauthorized 'RESET' teams have had maintenance performed without being documented. Other problems have included improper collimation, no purging and incorrect zero diopter settings and infinity focus. Doin' your own maintenance on binoculars must stop!

Always turn binoculars in to the right people

Any ANVIS turned into an unauthorized program must be reinspected by a qualified inspector to ensure the -10/20 standards are met.

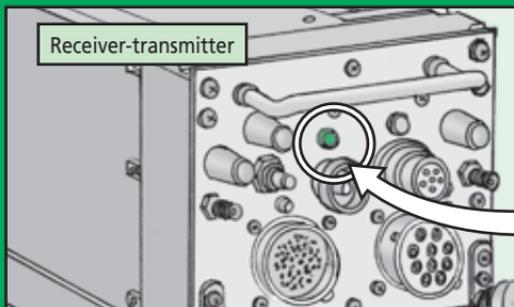
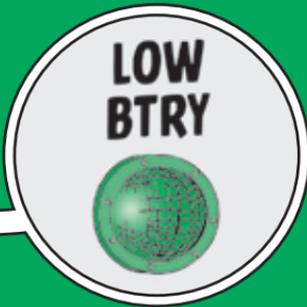
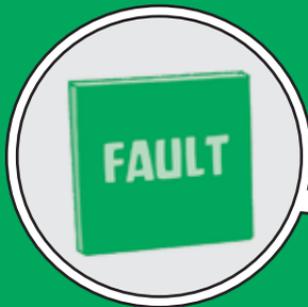
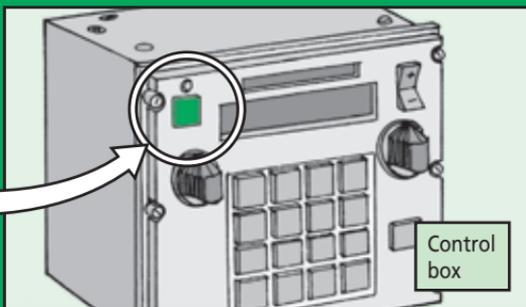
That means the battery replacement requirement has changed. For the new transponder battery, NSN 1635-01-529-0122, there is no specified battery time change requirement.

The BATTERY LOW status and FAULT indicator are displayed on the RCU. The LOW BTRY LED will illuminate on the transponder. When the LOW BTRY LED first lights up, replace the battery prior to the next mission.

The estimated battery life is 6 months (180 days) when the battery is installed in the operating transponder. The battery shelf life is estimated at 24 months (730 days). Rotate your stock by the Date Code stamped on the battery. For example, Date Code 5206 is Week 52, Year 2006. Unit folks, make a note of this until TM 11-1520-237-23 and TM 11-1520-240-23 series manuals are updated.
