Rub Out Steering Leaks

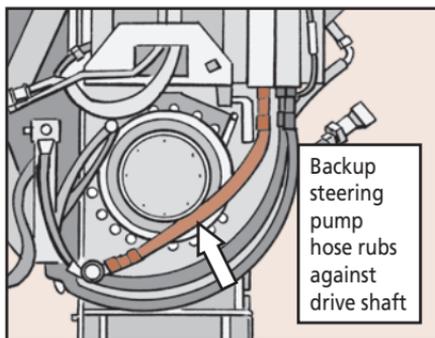
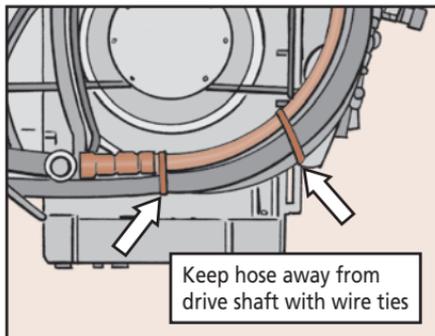
On some Strykers, there's not enough clearance between the drive shaft and the hose. That causes rubbing that leads to leaks.

During each Stryker's next scheduled maintenance, open the rear engine access panel and look at the rear of the power pack where the drive shaft connects to the transfer case. If the backup steering pump hose is touching the drive shaft, tie the hose to the main steering and auxiliary hoses using two cable ties, NSN 5975-00-984-6582.

To remind you of the new routing for the backup steering pump hose, a note is being added to the procedures for removal and installation of the power pack. See the Power Pack Assembly Replacement section of IETM 9-2355-311-13&P for more information on proper routing of the hose.
