Geared Hub Washers Can Deadline

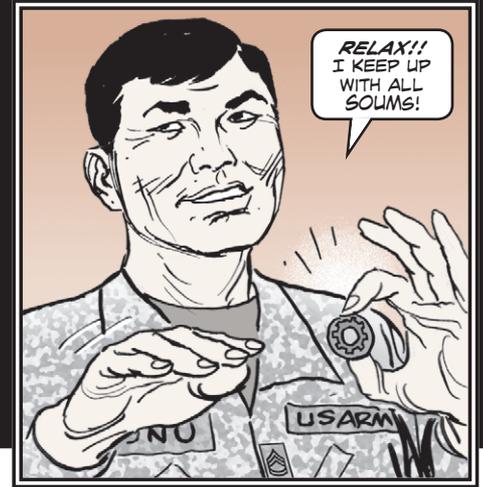
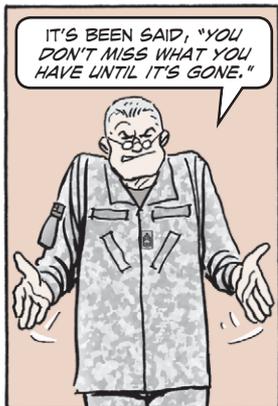
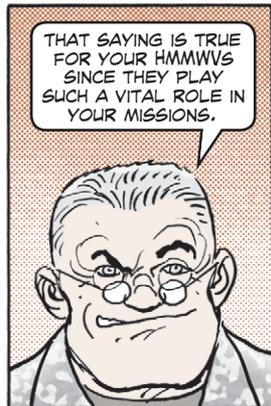
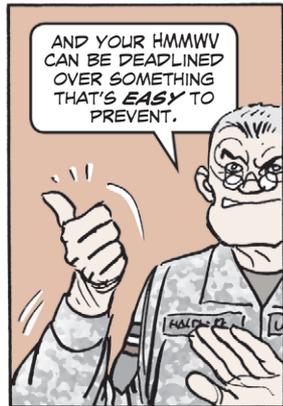
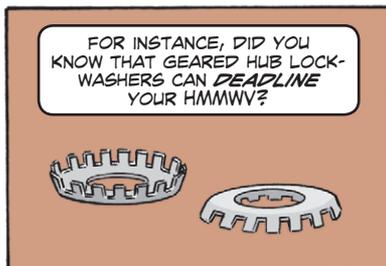
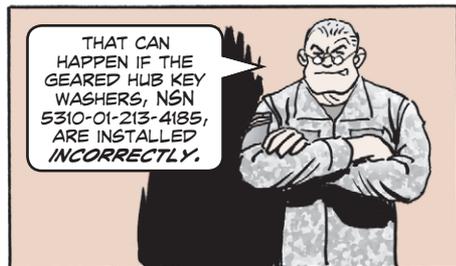
This isn't a new problem, but it's one that bears repeating. If your HMMWV's geared hub lockwashers are not bent properly into the locknut slots, then the tabs are more likely to crack or break off. That increases the chances that the locknut will loosen and come off, which could cause a wheel to fall off.

And if the washer was installed incorrectly, the lock tabs may not seat fully in the lockwasher slots. Then the spindle lock nut may back off in the hub assembly and your HMMWV could lose a wheel while moving. So pay attention to detail when installing geared hub lockwashers.

Remember the bottom line the next time you need to replace your lockwasher. After everything is tightened, make sure that the tabs are bent correctly into the slots in the nut. That can prevent a deadlined HMMWV.
