M1070P1
HET Tractor...

Remove the Rub

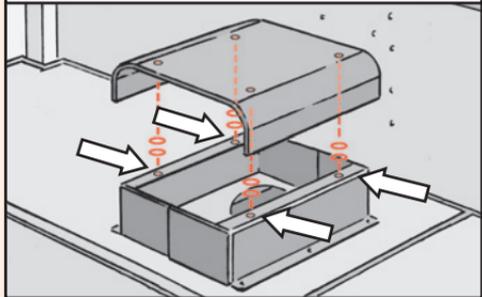
There's not enough clearance between the manifold and the armor plate. The two vibrate and rub against each other until the manifold finally fails.

Put two flat washers on each mounting hole between armor plate and seat support

1. Remove the driver's seat following the instructions starting on Page 16-54 of TM 9-2320-360-20-2.
2. Remove the armor panel. See Fig 3-88 in TB 9-2320-360-13&P-2 for help.
3. Install two flat washers, NSN 5310-00-081-4219, on top of each of the seat support's four mounting holes.
4. Reinstall the armor plate using new locking nuts, NSN 5310-00-814-0673.
5. Reinstall the driver's seat.

The washers provide enough clearance between the armor plate and the CTIS manifold to prevent the rubbing problem.
