# ARMOR WEAKENS CAB MOUNTS

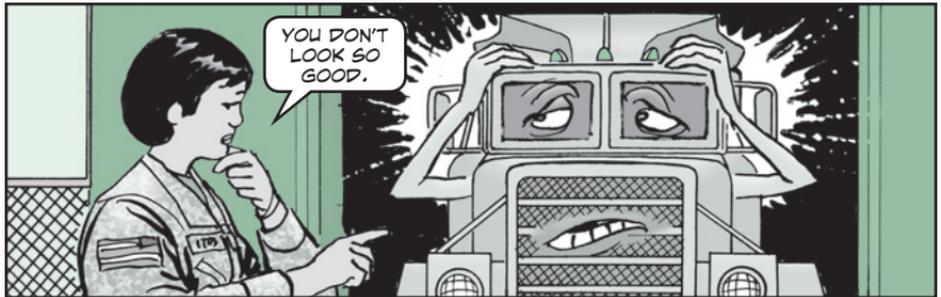
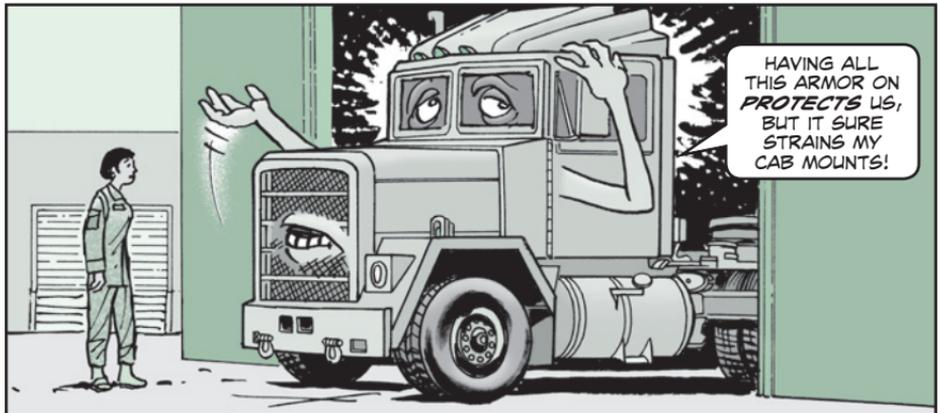
**F**ront and rear cab mounts and the rear cab mount structure on the Freightliner M915 family of vehicles (FOV) have been stressed with the application of the add-on armor kit. The cab could separate from the chassis or steering loss could occur if this problem isn't fixed.

TACOM SOUMs 06-022 and 07-005 addressed this problem and gave repair guidance per the TM and an engineering solution, so this isn't a new issue. **But since there's cab damage that those repairs can't correct, mechanics must use the procedures given in TACOM SOUM 07-011 immediately.** Then make weekly checks to ensure the cab is holding up.
