# SMOOTHER GUN ELEVATION SHIFTING

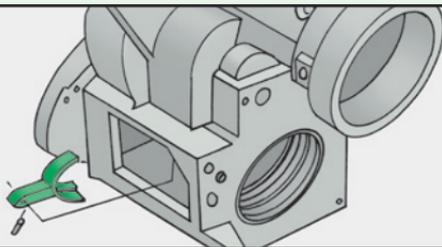
When you do a diagnostic test, it usually faults out the GED assembly or motor. But when I've investigated, I've found the real problem is that either the shifter fork (Item 101 in Fig 62 of TM 9-2350-294-24P-2) has broken or the fork's gear has rusted in place.

Cleaning and lubing shifter fork gear shaft helps prevent fork from breaking or rusting in place

Of course, it's much cheaper to replace the fork than the whole GED. And you can help prevent the fork from breaking or rusting in place by cleaning and lubing the shaft the gear slides on at least every six months.

- Remove the GED assembly (WP 0219 00-1 in TM 9-2350-294-20-2).
- Remove manual drive housing (WP 0034 00-1 in TM 9-2350-294-34-2).
- Remove manual support (WP 0031 00-1 in -34-2).
- Remove sensitive switch (WP 0031 00-1 in -34-2).
- Clean the shaft with solvent and lube it with molybdenum oil, NSN 9150-01-217-3103.
- Install the sensitive switch (WP 0031 00-6 in -34-2). If old switch is re-used, begin on 00-7.
- Install manual support (WP 0031 00-10 in -34-2).
- Install manual drive housing (WP 0034 00-31 in -34-2).
- Install GED assembly (WP 0219 00-7 in -20-2-2).
