# Gearbox Servicing Plug

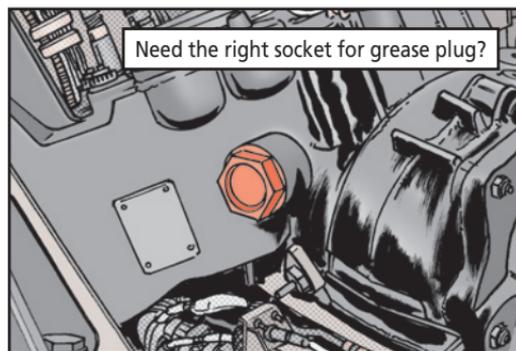
Problem is, the TM 1-1520-Longbow Apache IETM says to use a socket from the locker. But to use it, mechanics have to shave down the inside of the socket to force it to fit. But that creates more work and the socket still won't fit properly anyway.

In the end, after all the shaving is done, the servicing plug usually gets worn out, stripped or damaged after it's removed from the intermediate gearbox.

Get rid of your plug problem removal by ordering a 1 <sup>5</sup>/<sub>16</sub>-in socket, NSN 5120-01-335-0855, that's a perfect fit.

NSN 5120-01-335-0855 will get you the right one
