NOT SO QUICK ON THE DISCONNECT

CHECK FOR CRACKED CAPS

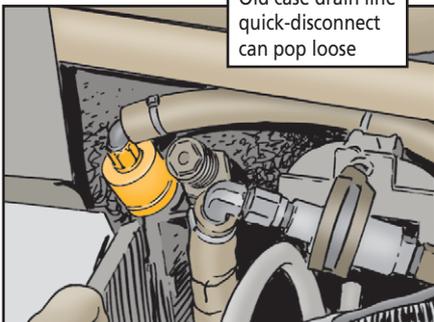
The case drain line sits back in a corner, so if you still have an old QD, NSN 4730-01-081-2106, installed, things can be a little tricky. Those old QDs may seem to be securely attached only to pop loose later. And a loose connection increases the chance of an engine fire and increases hydraulic pressure and temperature that could ruin the hydraulic pump.

That problem has been fixed with a replacement QD, NSN 4730-01-509-1330. This "sure lock" QD provides a one-way only connect feature that ensures a positive lock.

If you're having trouble keeping the case drain line QD connected, it could be that your tank still has the old one installed. If your QD is orange in color, it's the old one. Get your mechanic to change out the old unserviceable QD at the next scheduled service or when the powerpack is pulled for non-scheduled maintenance.

The new QD will be a dark color and have two notches at the opening end.

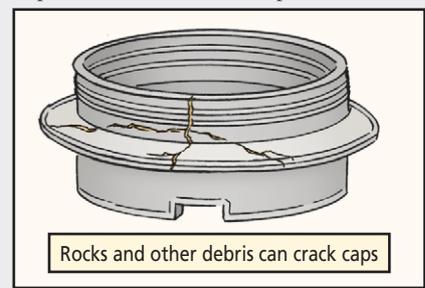
Crewmen, the tracks on your M1-series tank throw up a lot of rocks and debris during cross-country operation. It only takes one thrown at the right angle and speed to put a crack in one of the plastic roadwheel hub caps.

Oil leaks out of the cap and eventually the hub bearings seize up. That's an expensive and time-consuming repair.

You can help prevent that problem by checking the hub caps frequently during stops. If you notice an oil leak, tell your mechanic.

He'll install a new cap, NSN 2530-01-063-5862, and torque it to 40-60 lb-ft like it says in the -20-1-4 TMs.
