# TOO TIGHT IS TOO MUCH

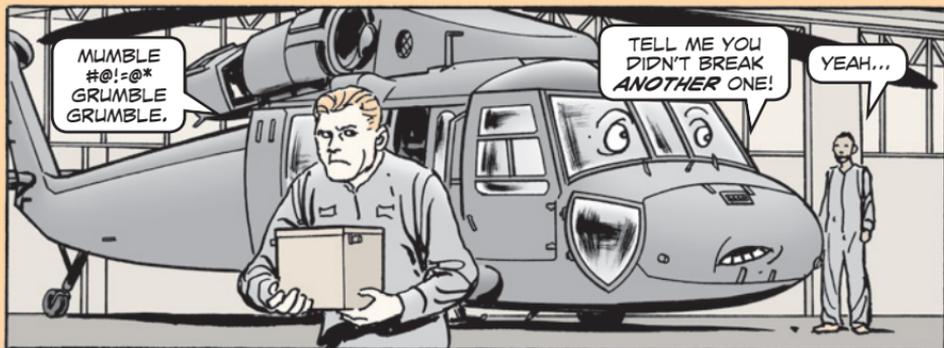
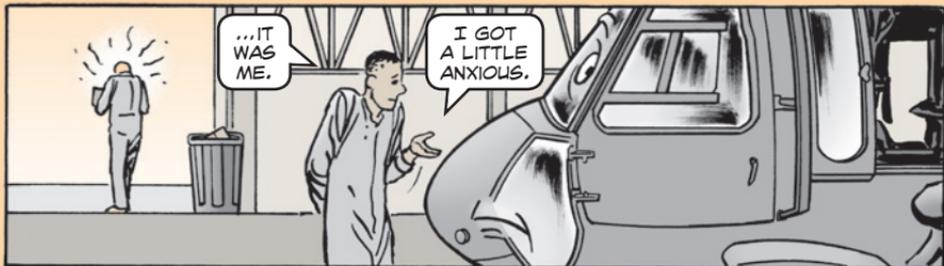
New mechanics and not-so-new mechanics, one extra twist to the wing nuts on the holddowns for the sealed lead-acid battery (SLAB), NSN 6140-01-286-6294, and you might hear a crack. That's the sound of the battery snapping.

Hand tight on the wing nut is tight enough. The battery tabs are not that sturdy, so they crack easily when the wing nut is tightened too much.

If you've already heard that sound, it means you've broken another battery locking tab. That makes the SLAB unserviceable.

Pay attention and follow the instructions on the battery's caution label. Don't work up a sweat when tightening the wing nuts. If you break a tab, you'll be replacing the SLAB battery at \$690 a pop.

Remember, for an unserviceable battery there is no 'wing and a prayer' solution—just replace it.
