# Helmet Communication Cord Problems

ALSE techs, have you ordered a replacement communications cord, NSN 5995-01-391-9894, for your HGU-56/P aircrew integrated helmet system (AIHS)?

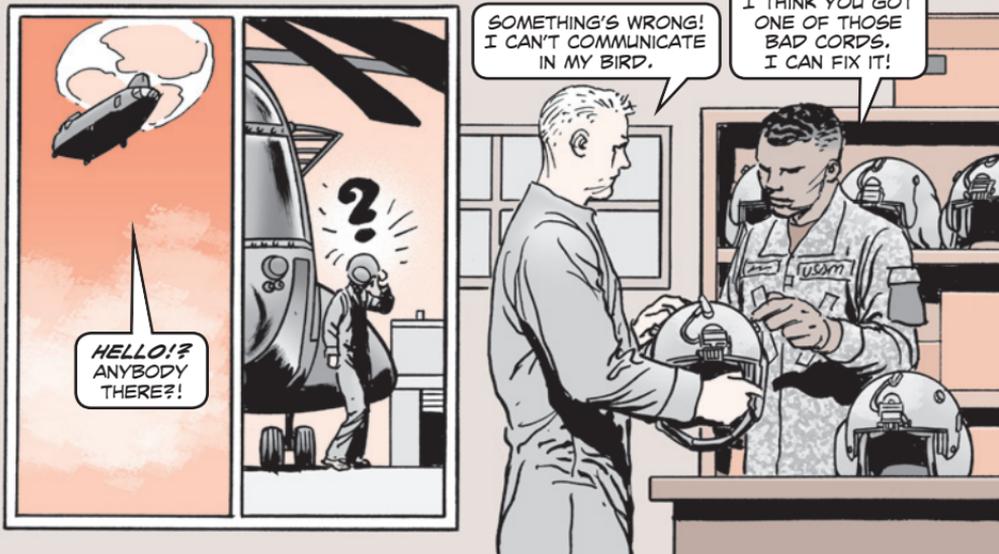
Some of the cords were incorrectly manufactured. The cord should have a mounting bracket factory-crimped and shrink-wrapped around the female microphone connector. The incorrectly manufactured cords have the mounting bracket and shrink wrap packaged loosely with the cord. If the ALSE technician attempts to crimp the bracket with pliers, he'll likely damage the female microphone connector. The shrink wrap would then hide the damage and could lead to an in-flight failure.

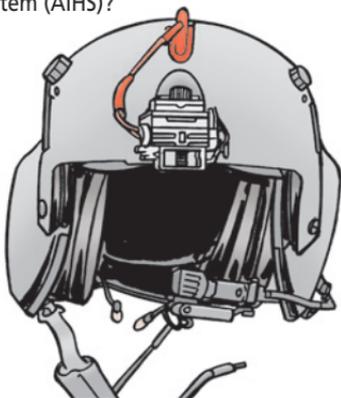
Some bad cords snuck into the supply system. Check your cord now! If it's stamped either 1680-ALSE-198-1 or 1680-ALSE-210-1, it may be bad.

Inspect cord for problems

To get turn-in credit, submit a Quality Deficiency Report (QDR). The quickest way to get that done is through the Joint Deficiency Reporting System (JDRS) website. Go to:

To process the QDR faster, make sure you refer to QDR W31NWX050414.
