HGU-56P
AIHS...

Helmet Communication

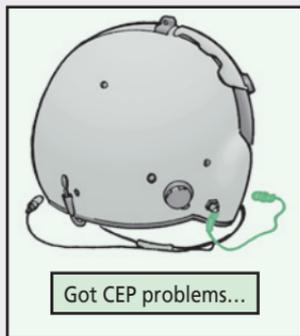
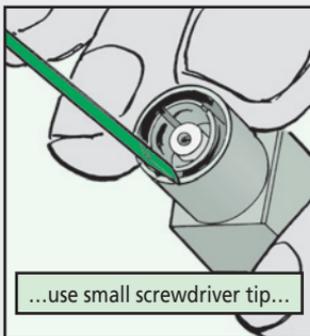
If you frequently push in and pull out the communication earplug (CEP) connector, NSN 5965-01-504-0077, the connector prongs can bend out of place. That can cause intermittent communication failures.

The problem is caused by poor contact in the right angle connector. The tabs in the connector are bending away from the center and losing contact with the center jack on the helmet.

However, **you** can fix the problem. Just use a push pin or a jeweler's screwdriver set, NSN 5120-00-288-8739, to bend the four prongs slightly toward the center of the connector to establish good contact. Make sure you reattach the connector to the helmet to see that it seats properly and that the prongs are not pushed in too far.
