UH-60...

TAIL ROTOR BLADES CRACKING UP?

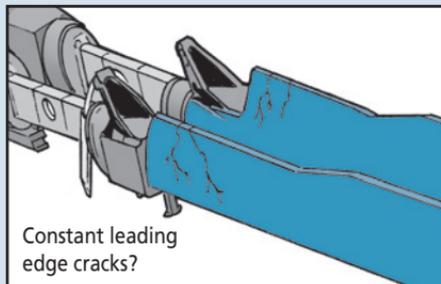
When the leading edge cracks, eyeball the pitch horn area. That's because the culprit causing the cracks could be a worn out and loose structural fitting, NSN 1560-01-100-1701, and retainer assembly, NSN 1615-01-082-9253, inside the pitch horn.

The pitch horn, the hollow part of the tail rotor blade, contains a structural fitting. When the fitting breaks loose, it moves and causes splits in the blade's leading edge.

Check for
loose fitting
and retainer

The next time you repair a tail rotor blade leading edge like it says in WP 0585 of TM 1-1520-237-23-7, make sure you don't have a shake, rattle and roll inside the pitch horn.
