# Wrasslin' With the Road Arms

**M**echanics, the road arm bearings, NSN 3120-01-102-4700 (outer) and NSN 3120-01-102-4701 (inner), on some Bradleys have been failing. Soft bearings are part of the problem, but lack of lubrication is also a culprit. The added weight of belly armor and reactive armor tiles just compounds the problem.

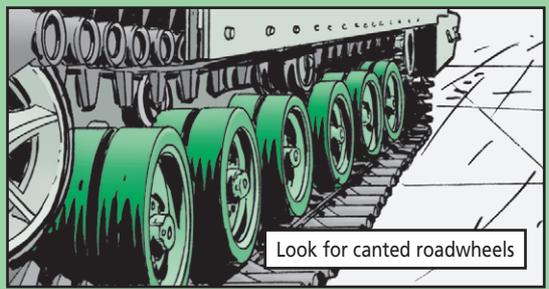
1. Perform a visual inspection. Are any of the road arm seals leaking or protruding? Are any of the road arms out of alignment relative to the hull and in comparison with other road arms? Are any of the road arms canted at an angle?

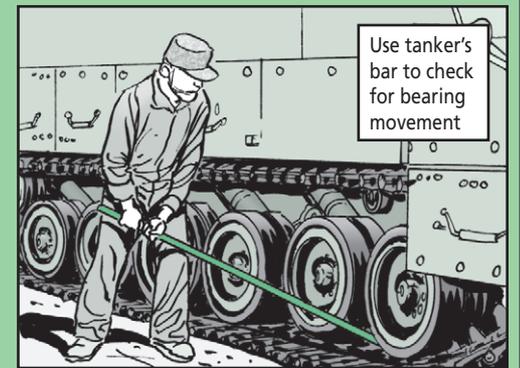
2. Use a tanker's bar to pry the roadwheel up from the track. This is a quick check for a broken torsion bar, but you can also use it to watch and feel for movement in the road arm that signals free play in the bearings.

3. Put the tanker's bar between the double roadwheels and try to move the roadwheels on the spindle. Movement indicates bearing problems.

If any of these three tests lead you to believe there's a problem, lift the suspect roadwheels with the dogbone tool, NSN 4910-01-118-7711. With the roadwheels in the air and no longer supporting the vehicle's weight, use the tanker's bar to test for movement again. If the roadwheels move, you need to disassemble and repair the bearings.
