M40A1/
M42A2
Masks...

WEED OUT BAD GASKETS

CBRN SPECIALISTS, SOME BAD SIDE PORT GASKETS, NSN 5330-01-260-8702, FOR THE M40A1/M42A2 MASKS HAVE GOTTEN INTO THE SUPPLY SYSTEM.

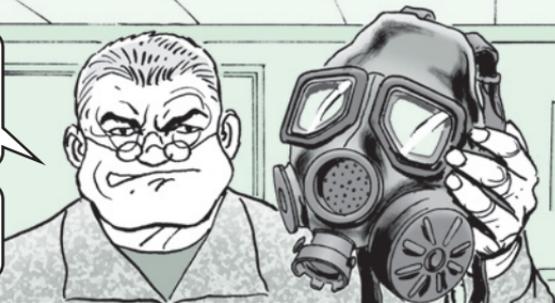
THE GASKETS ARE TOO SMALL AND WILL HURT THE MASK'S SEAL IN THE SIDE VOICEMITTER AREA.

Immediately check your stock of side port gaskets for contract number SPM 500-03-d-0239-0130. If you're unable to ID the contract number, just check the size of the gaskets. The correct gasket has an outside diameter of 1.6 inches. The incorrect gasket's is 1.2 inches.

Correct gasket is
1.6 inches in diameter

Bad gasket is
1.2 inches

If you find any bad gaskets, submit a PQDR through the AEPS website:

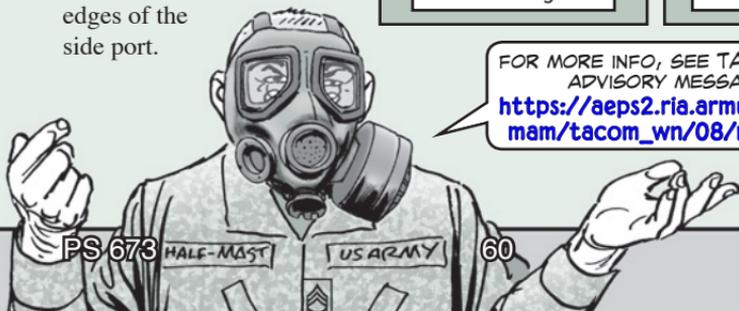
Hold the side port assembly opening under a strong enough light that you can clearly see the gasket sandwiched between the side voicemitter and the side port housing. If the correct gasket is installed, the edge of the gasket will be flush with the edges of the side port.

Correct gasket will be flush
around the edges of side port

Correct with gasket

Wrong or NO gasket
