IS THERE A CRACK IN YOUR RACK?

TACOM GROUND PRECAUTIONARY ACTION (GPA) MESSAGE 08-018 TIPPED UNITS OFF TO A PROBLEM WITH CRACKING FMTV RADIATOR ARMOR CAB KITS (RACK).

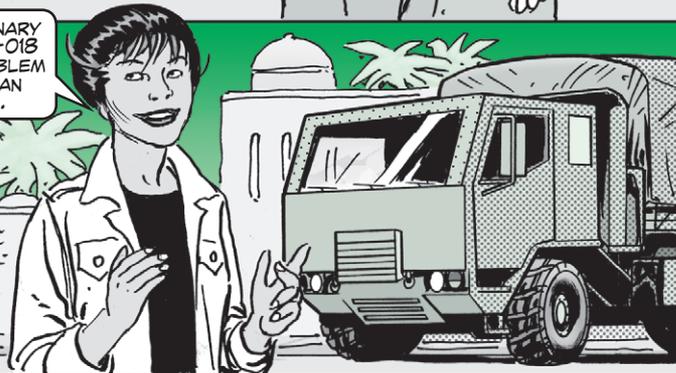
A GROWING NUMBER OF RACK-EQUIPPED FMTVS ARE SHOWING FATIGUE CRACKS IN THE CAB STRUCTURE.

EXTENDED USE OF THESE RACK CABS CAUSED THESE CRACKS, AND THEY **MUST** BE FIXED BEFORE THEY CRACK BEYOND REPAIR.

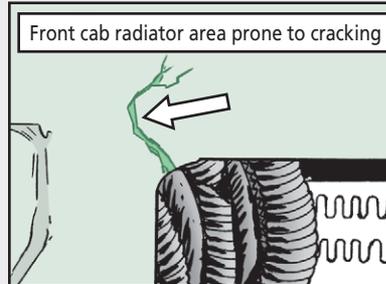
Cab Structure Inspection Guidance

Inspect your RACK-equipped FMTV truck's cab structure by lowering the front grill cover. Then visually inspect the cab skin and structures surrounding the radiator.

Single or multiple cracks in this area can't be longer than **three inches**. If they are, the cab needs **immediate** repair and installation of a new RACK support repair kit.

On the other hand, if cracks are **less than three inches long**, mark the end points of the crack or cracks. Then inspect these cracks during each operator-level PMCS to watch for increased cracking. Repairs should be made as your mission permits, but you have to fix these cracks **within 90 days**.

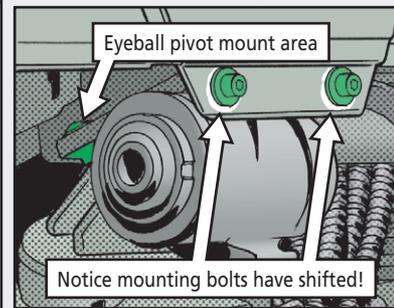
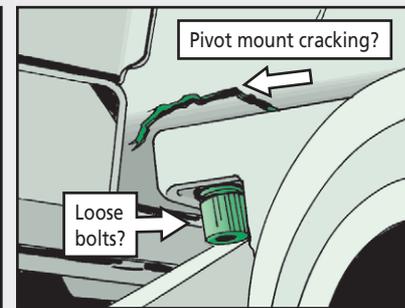
Cab Pivot Block Area Inspection

Visually inspect both cab pivot block areas where they attach to the pivot block frame for cracks. If cab mount cracking exceeds $\frac{3}{4}$ inch in the pivot block mount area, your FMTV truck needs **immediate** repair! So mechanics, eyeball this link to find out how to fix cab mount cracks:

If cracks are present along the pivot block area that are less than $\frac{3}{4}$ inch, mark the ends of the crack for future reference. Operators should inspect the truck at each PMCS to make sure cracks don't go over the crack limits. You can operate the truck normally until the mission allows you to get the cab pivot mount repair bracket installed. But this repair needs to happen within 90 days after discovering the crack.

Go to the cab replacement maintenance procedures in chapter 15-2 of TM 9-2320-366-34-3 for all initial setup instructions. It takes about 3 to 4 hours to install the kit on your FMTV truck. And make sure you use a *drill press* when you drill the holes. Using hand drill motors destroys the drill bits.
