Correcting Trigger Block Problems

FIELD REPAIRMEN, IF THE TRIGGER BLOCK FROM MWO 9-1005-213-30-1 HAS BEEN APPLIED TO YOUR M2 MACHINE GUNS, THERE ARE A COUPLE OF PROBLEMS YOU NEED TO CHECK FOR BEFORE THE WEAPONS LEAVE THE ARMS ROOM.

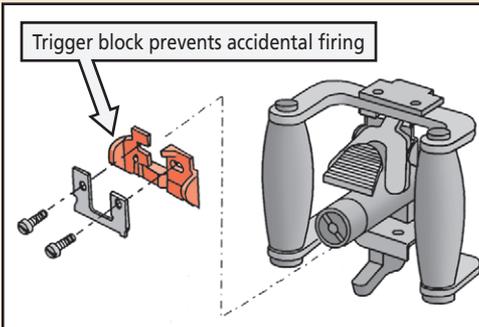
Back Plate Hook

The back plate hook engages the bolt latch release lever for AUTO MODE. Sometimes the hook can prevent the trigger block from sliding between FIRE and SAFE because the hook is bent so that it holds the bolt latch release too tightly against the trigger assembly. This happens during AUTO MODE, but not SINGLE SHOT MODE.

Solve this problem by slightly bending the hook outward. The hook should keep the bolt latch release lever in the full-down position for AUTO MODE, but still let the trigger block assembly function correctly.

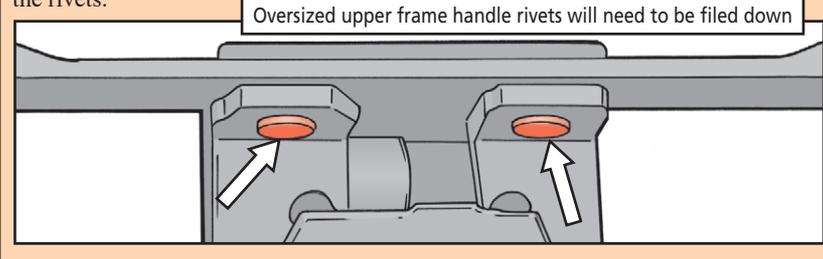
Rivets Too Big

Sometimes the rivets for the upper frame handles are big enough that they interfere with the trigger block. The trigger block can't slide between FIRE and SAFE.

Correct this problem by filing the rivets enough so that they don't interfere with the trigger block. File between the face of the backplate and the rear side of the rivet. When you're done filing, put some solid film lubricant, NSN 9150-00-754-0064, on the rivets.

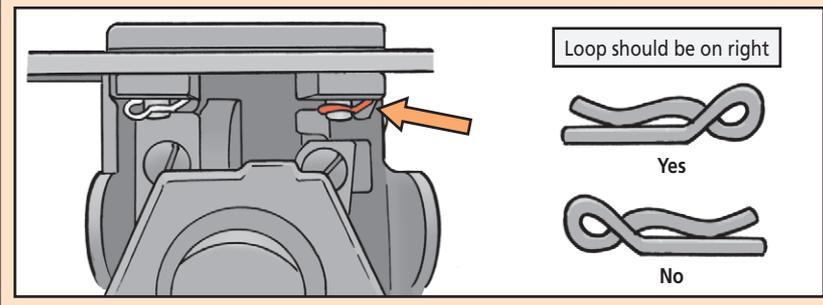
Backplate Lock Pins

There is also a possible problem with the lock pins on the backplate handle when the trigger block is installed. If the upper right frame handle lock pin is installed with the loop end on the left, it interferes with the trigger block sliding from FIRE to SAFE. Solve the problem by reversing the lock pin so the loop end is on the right.
