LOOSE SENSOR WIRE

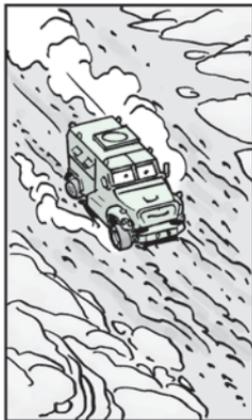
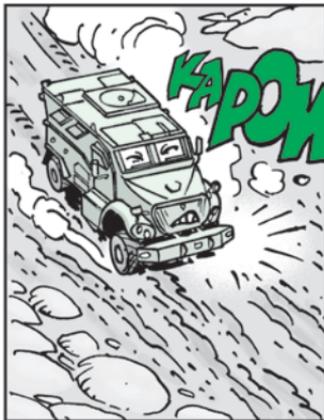
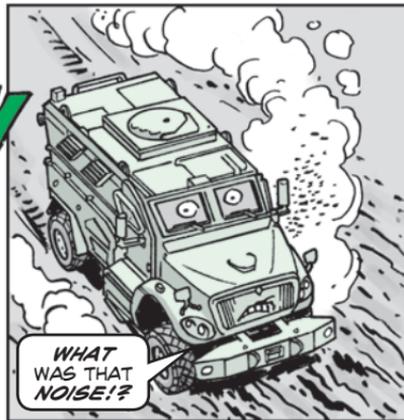
MRAP users, a loose sensor wire can cause the engine fire suppression system (FSS) to activate—without warning—while your MaxxPro is running.

When this happens, you'll hear a loud explosion go off under the hood, followed by a fine, gray chemical dust that covers the engine and everything else nearby. Talk about a mess!

Here's the problem: high operating temperatures in SWA cause the wire's sensor clips to come loose or just fall off. A loose wire that touches the engine makes the suppression system do its thing—that is, go off!

So, eyeball the sensor clips to see if they're loose. Find a loose clip? If so, use a $\frac{3}{16}$ -in diameter rivet, NSN 5320-01-232-7730, and rivet the clip back in place. Then use sealant, NSN 8040-01-010-8758, to seal both sides of the sensor clip, under and on top of the hood. For more information, see TACOM MAM 08-056.
