REPLACE THE 3-KW TQG MUFFLER HARDWARE

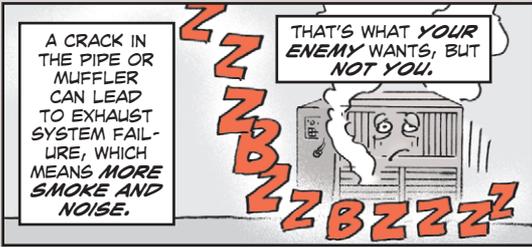
THIS VIBRATION LOOSENS THE MOUNTING HARDWARE AND LEADS TO CRACKS IN THE EXHAUST PIPE.

A CRACK IN THE PIPE OR MUFFLER CAN LEAD TO EXHAUST SYSTEM FAILURE, WHICH MEANS **MORE SMOKE AND NOISE.**

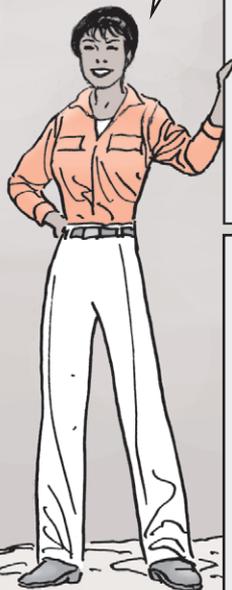
It could be that this job has already been done on your generator. Check the top of the cap screws. If the top has a raised W.T 10.9 and is yellow, you're good. If it has a raised FS 8.8 and is black, you're bad. Replace the hardware!
