# Tanker Trouble - shooting Tips

I've got some ideas that will help your readers that work on HEMTT fuel tankers. Your article on page 16 of PS 664 (Mar 08) about M978 tankers not taking fuel did not address the problem that many tankers are experiencing. The problem we've seen in our Aviation Ground Support unit is debris in the pressure line going from under the V12 precheck valve to the V19 valve's top level (jet sensor) shut off venturi.

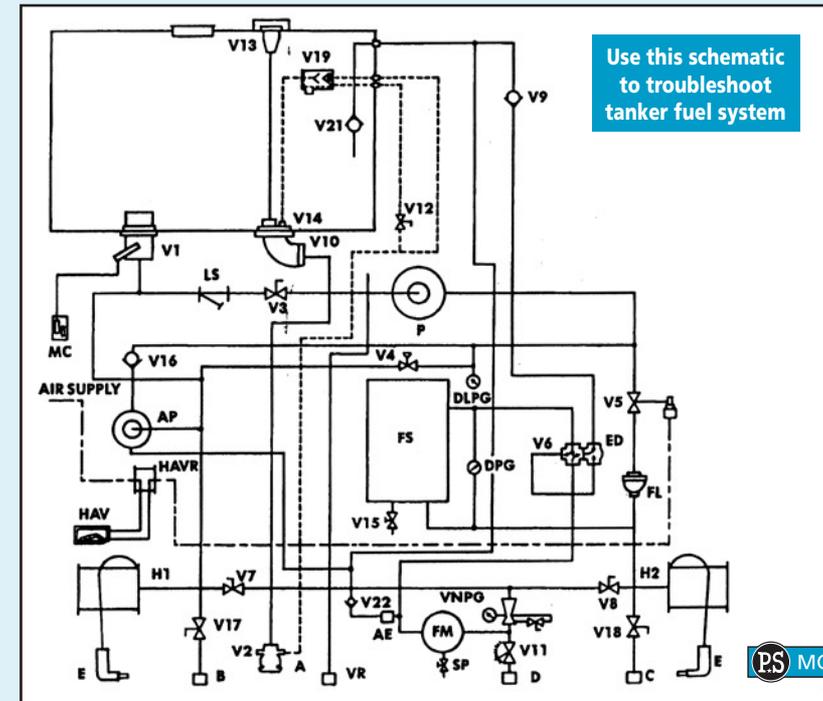
For newly RESET HEMTT -A2 tankers, and generally for all HEMTT tankers that fail to recirculate or bottom load, do this. Trace the plastic lines connected to the V19 to make sure they are installed properly. By the way, you'll find a picture of these lines in the HEMTT maintenance and parts manuals. The picture in the HEMTT parts manual has the right and left sides reversed.

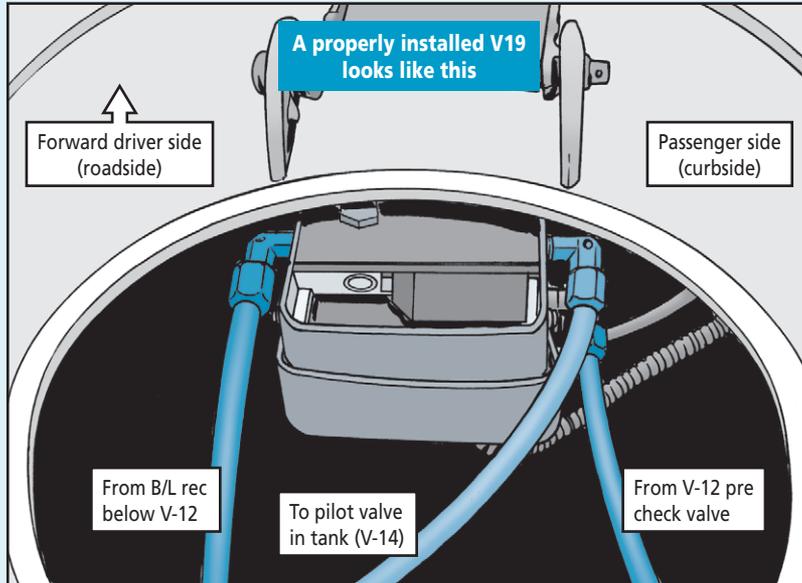
- A.** The INPUT plastic fuel line should be installed on the left (driver) side of the V19. This line comes from the fitting located below the V12 (the precheck valve) and gets pressure directly from the recirculation/bottom loading port where you connect the D-1 nozzle.
- B.** The plastic line to the pilot valve (in the bottom of the fuel tank just above the V10) should be installed on the top right (passenger) side of the V19 jet sensor box.
- C.** The plastic line from the V12 (the precheck valve) should also be installed on the bottom right (passenger side) of the V19.

**D.** Inspect the brass elbows that connect all three lines to the V19. If you can move them at all, they are too loose. So remove, clean and reinstall them securely using thread seal tape on the threads going into the V19. Do not put tape on the threads that go into the brass nut end where the plastic fuel lines attach. Tape in the wrong place could add debris to the line, and is not needed for the fitting-to-tube connection.
