# COLD WEATHER CAN CAUSE LEAKS

**C**rewmen, if you're operating your M777A2 howitzer in very cold conditions, keep an eye on the suspension hydrostruts.

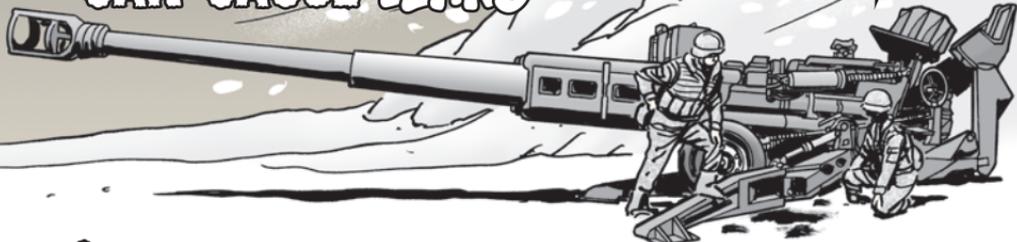
THE HYDROSTRUT ASSEMBLY IS LEAKING LIKE A SIEVE!

HOW ARE WE EVER GONNA RAISE THIS HOWITZER?

Units at Ft Wainwright, AK, noticed Class III leaks coming from the hydrostrut vent ports when they tried to raise howitzers that had been stored outdoors in temperatures below -10°F.

Turns out there's a slight problem between the hydraulic fluid and the hydrostrut piston seal, NSN 5330-99-679-8380. Over time, the seal loses its elasticity, especially in extremely cold weather. That can create leaks when the thermometer takes a nose dive.

If you notice a Class III leak at the hydrostrut vent valve, stop trying to raise the howitzer immediately. Lower the howitzer to the ground using the suspension levers and take the following action:

1. Deploy the wheel arm assemblies into the raised position, like it says on Page 2-124 of TM 9-1025-215-10 (Jun 06 w/Ch 3, Jul 08).
2. Return the wheel arm assemblies to the towing position (Page 2-175).
3. Try to build pressure with the suspension pumps, then relieve the pressure using the suspension levers.

Repeat these steps several times. That should energize the seals and help stop the hydraulic fluid leak. Once you're finished, make sure you check the suspension oil fluid level. If it's low, notify your mechanic.
