METAL-TO-METAL CONTACT BETWEEN YOUR BRADLEY'S TURRET AND TOW LAUNCHER IS NOT A GOOD THING!

Running Interference for TOW Launcher

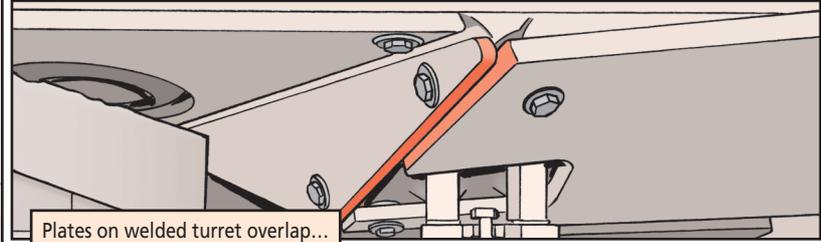
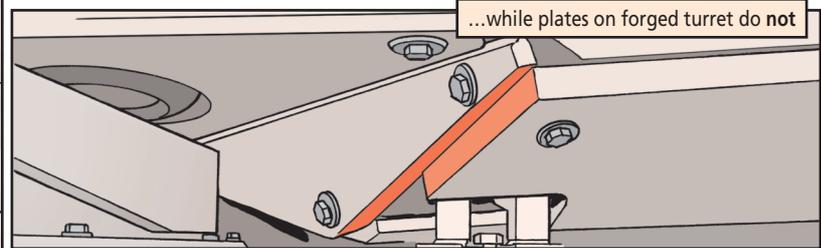
The fix for the problem is fairly simple:
7. You must determine whether the turret is forged or welded. Look at the point where the two bolt-on armor plates, NSN 9515-01-267-8108 and NSN 9515-01-268-3375, meet.

If the two plates overlap, do nothing. The turret is welded and you won't have the screw interference problem. If the two plates *don't* overlap, the turret is forged. Go on to Step 2.

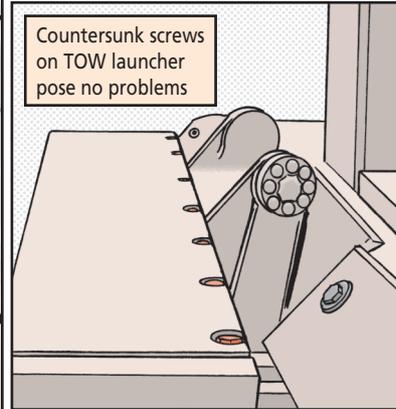
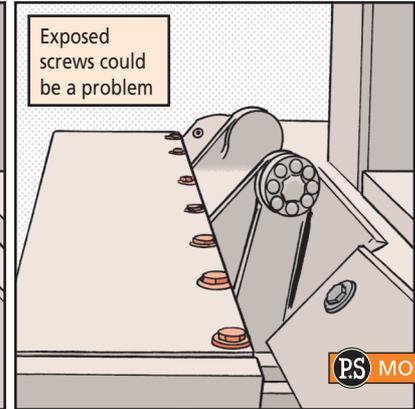
2. Check the screws attaching the armor plate, NSN 1005-01-110-7641, to the TOW launcher. Earlier versions of this armor plate used countersunk holes for the screws.

If the screws on the TOW launcher armor are countersunk, stop now. There is no interference problem. However, if the screws *aren't* countersunk, continue to Step 3.

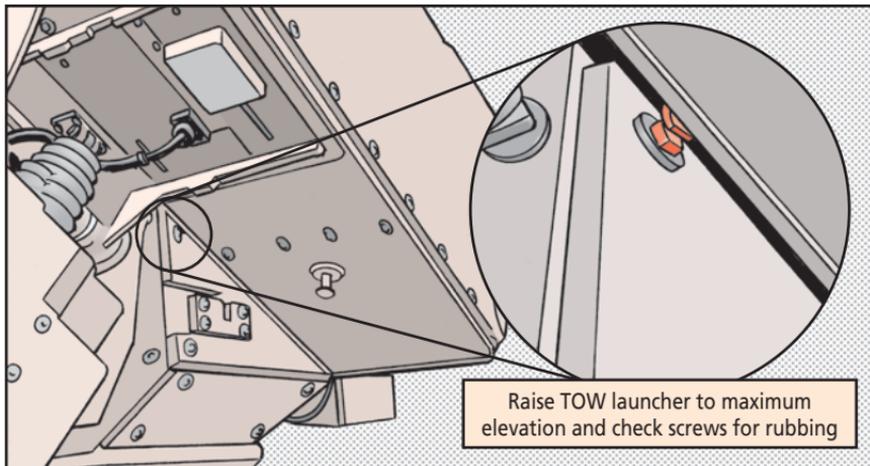
Some time back, we noticed a problem with interference between one screw on the Bradley's bolt-on armor and a second screw on the TOW launcher when it's positioned at maximum elevation.

The problem exists only on Bradleys that have forged turrets. Forged turrets are thicker than welded ones, so when armor plate is installed, the mounting hardware on these turrets is closer to the TOW launcher. That results in the interference between the two screws.

3. Raise the TOW launcher to its maximum elevation. Watch closely to see if the two screws hit. If they don't, stop here. If they do, continue to Step 4.

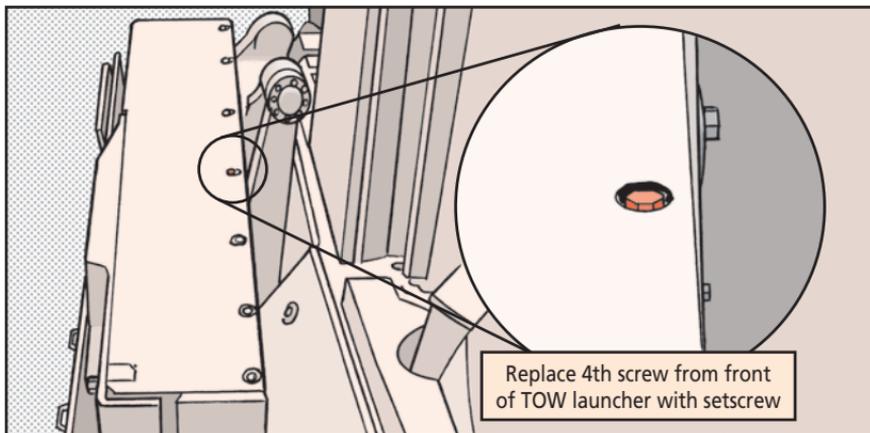
Once installed, the setscrew is flush with the armor plate, eliminating the interference problem.

4. Remove the $\frac{3}{8}$ -in screw at the fourth position from the front of the TOW launcher. Replace it with setscrew, NSN 5305-00-724-5888. Coat the setscrew threads with sealing compound, NSN 8030-01-014-5869, to hold it in place.
