# BOOM-OUTRIGGER PINS NEED LUBE

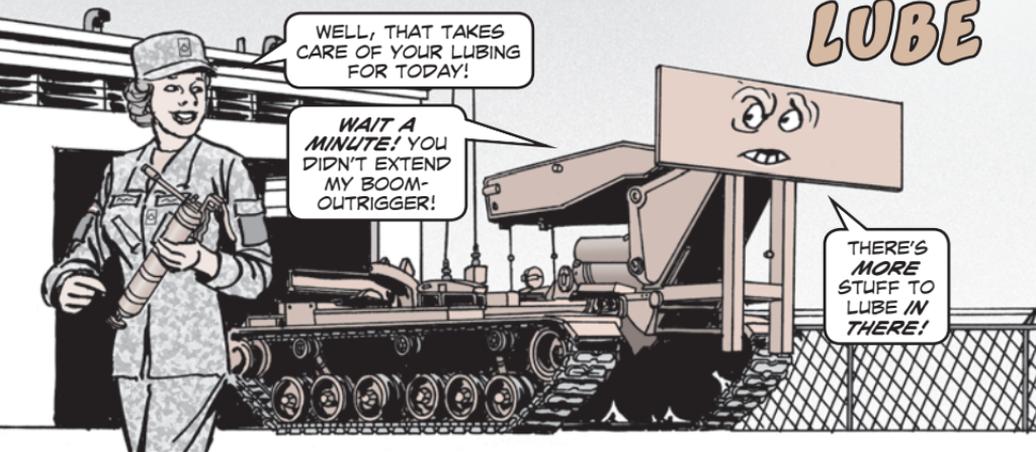
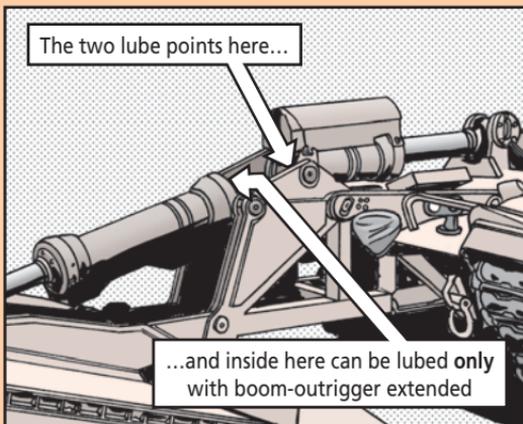
During overhaul of AVLBs at Anniston Army Depot, we're finding that the overhead cylinder cap pin and the tongue cylinder cap pin on the boom-outrigger aren't being lubed.

Most of the pins we see have seized up in the cylinders. They're not only hard to remove, but by the time we get them out, both pins are damaged and have to be replaced.

A lot of cost and hard work could be avoided if crewmen would remember to lube the pins quarterly with GAA. The four grease fittings (two for each pin) are hidden by the armor covers when the boom-outrigger is retracted. That's why they're so often overlooked.

Can you remind crews to extend the boom-outrigger and lube all four of the fittings during PMCS?
